**UNDERGROUND OPENINGS  
– OPERATIONS, MAINTENANCE AND REPAIR**  
Publication No. 17

**NORWEGIAN TUNNELLING SOCIETY**

**2008**

# **UNDERGROUND OPENINGS OPERATION, MAINTENANCE AND REPAIR**

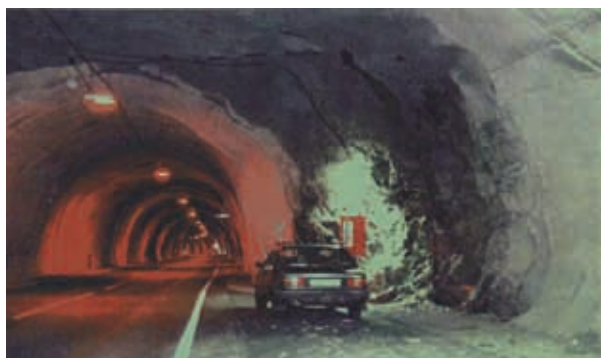
*Fig. 1: Typical situation inside a Norwegian low traffic tunnel*

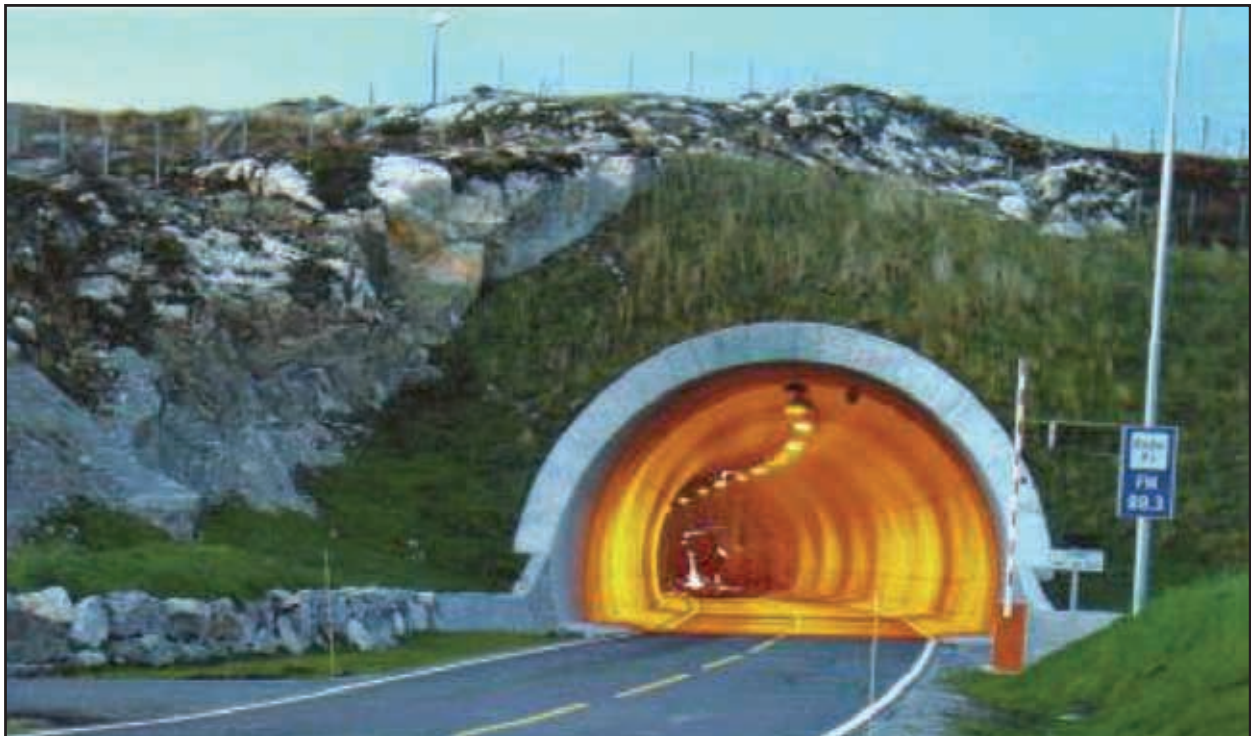
Fig.1 Portal of a Tunnel showing the barrier for closing the tunnel

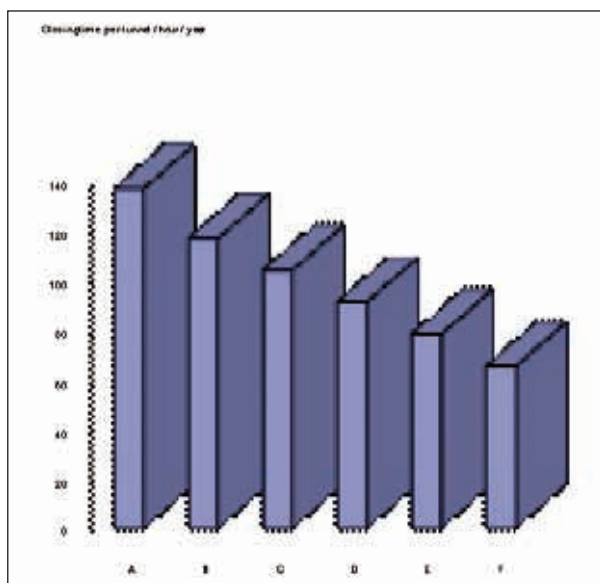
Fig.3 Tunnel closing time according to class of tunnel

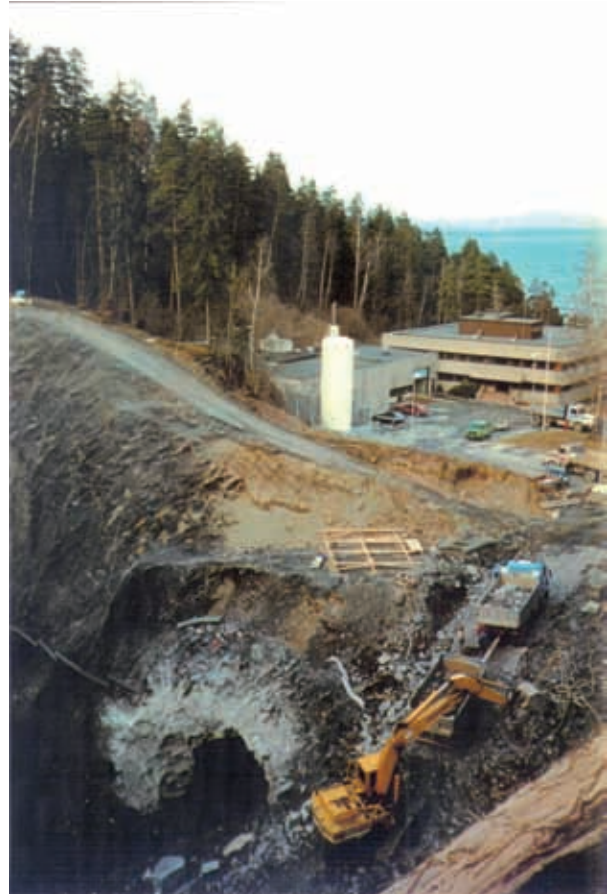
*VEAS waste water treatment plant west of Oslo*

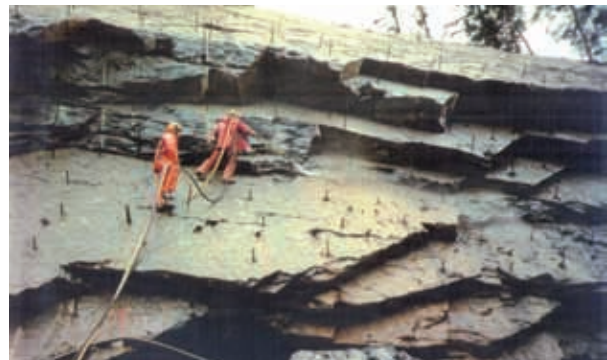
*Rock support outside new access. Also from the VEAS facilities.*

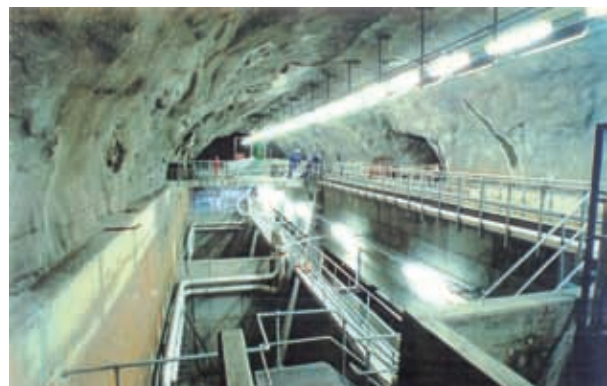
*VEAS waste water treatment plant, from one of several caverns.*

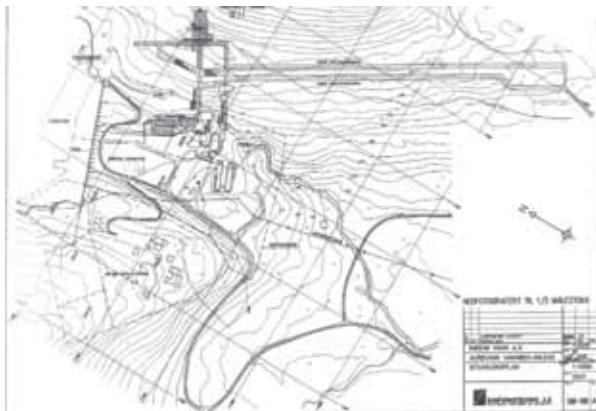
General layout of Aurevann facilities for potable water treatment.

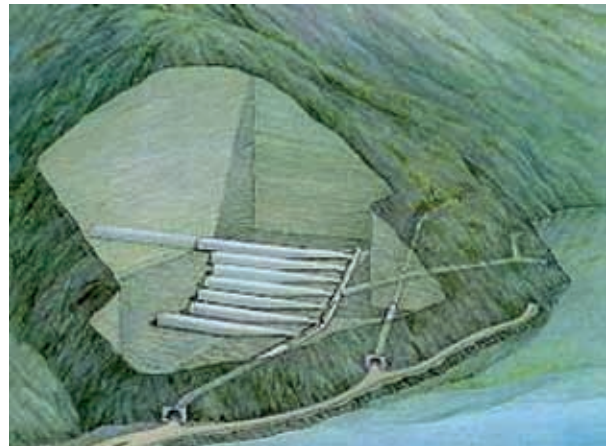
*Drawing of the Boliden Rock Caverns for storage of industrial waste*

In the rock caverns for storage of industrial waste at the Boliden Odda facilities in the western part of Norway, there will be no persons operating inside the storage caverns during the operational period. The bedrock is of good quality and minor rock slides are accepted. The temporary rock support measures installed during the construction period are thus considered to be sufficient as permanent rock support.

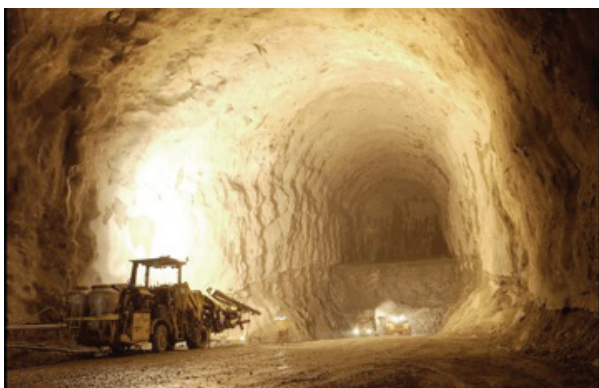
*Rock cavern for oil and gas storage*

The rock cavern concept for storage of oil and gas is feasible provided good quality rock mass. Like for the storage caverns for industrial waste, minor rock slides might be accepted. Damage to vital structures or installations inside the caverns must however be avoided since damage will have serious consequences with loss of production and income. Access to the caverns in the operational period is very limited if possible at all.

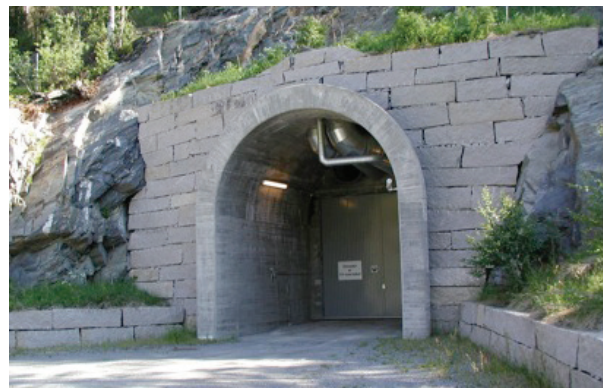
*The Himdalen Underground Storage of low and medium radioactive waste*

For the permanent storage of industrial waste at Boliden and the rock caverns for storage of low and medium radioactive waste at Himdalen in Norway, even the post closure stage had to be considered. The rock caverns including permanent rock support were designed for a period of more than 1000 years. Scenarios including operational accidents and human activities, sabotage and war plus natural events like earthquakes and long term climatic changes were included in the risk analysis and impact assessments.

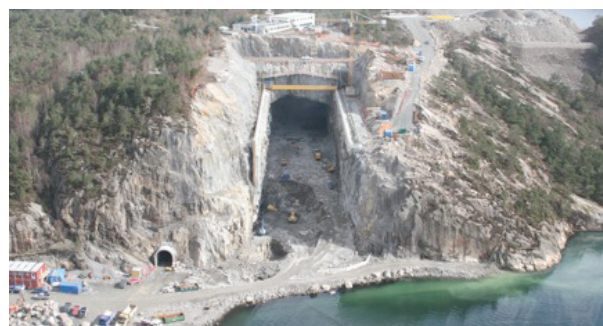
*The extended dry dock for the new navy vessels at Haakonsvern, Bergen*

The underground dry dock for maintenance and repair of navy vessels at Haakonsvern was completed in 1960. For maintenance of the new generation vessels delivered from 2006 onwards, the dry dock had to be extended in width and depth. Parts of the underground cavern were opened to give space for the new vessels. Thus, due to new requirements and need for rehabilitation, the lifetime of the old underground cavern was approximately 50 years.

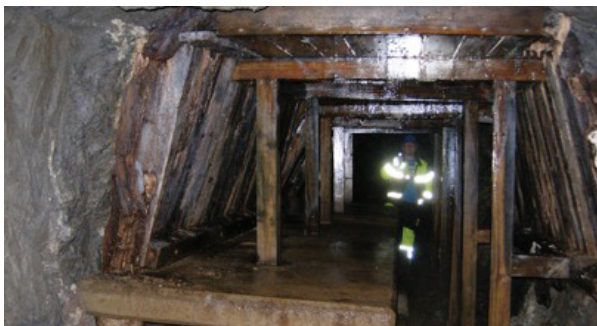
*Emma Hjort tunnel for fresh and drain water pipes – timber support – although in poor condition, parts of the timber supports are still intact after more than 50 years in operation*

Rock bolts, sprayed concrete and concrete lining are the most common support measures used in underground caverns and tunnels. Today, there are materials, corrosion protection methods and additives that makes lifetime of 50 – 100 years or more possible for the common support measures. Good quality concrete lining will have a lifetime of several hundreds of years in normal climatic and chemical environments. In water tunnels for different purposes there are examples that even unprotected steel bolts have only surface corrosion after more than 50 years in operation. Even timber support might have a long lifetime like in the Emma Hjort water tunnel (a tunnel in the western suburbs of Oslo).

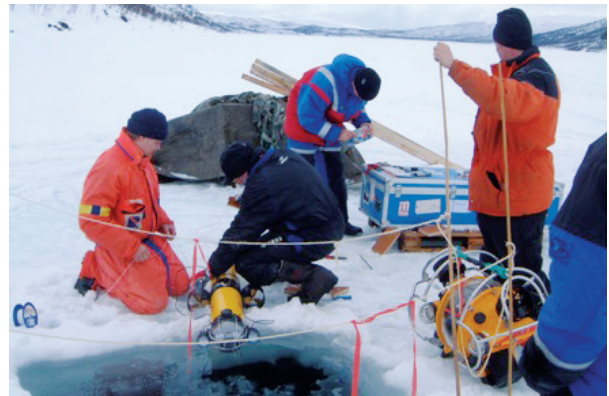
*The partly collapsed tunnel between the lakes Bleikvatn and Røssvatn was not accessible and subsea ROV vessels were used for inspection*

ity of 12 m<sup>3</sup>/sec. Due to collapses and slides, the capacity has gradually been decreased to 3 m<sup>3</sup>/sec. Today a new tunnel is constructed to replace the old one. In this case the lifetime of the old tunnel has been less than 50 years. The rock support measures were installed for the construction period only and there was probably no rock support strategy for the operational period.

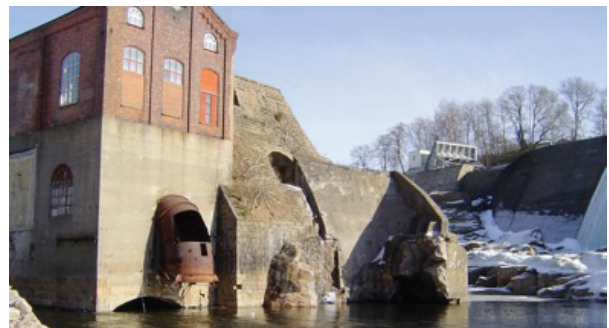
*Before the cofferdam was constructed, the old tailrace tunnel at Borregaard hydropower plant was filled with water*

The first stage of the Borregaard Hydropower Plant in Sarpsborg (100 km south of Oslo) was completed in 1906. Extensions took place in several steps until recently. The tunnel system was inspected for the first time in January 2008. The tunnel system including the concrete lining was in good condition. Necessary rehabilitation of the rock support was limited to scattered rock bolting. In this case, the lifetime of the rock support measures was more than 100 years.

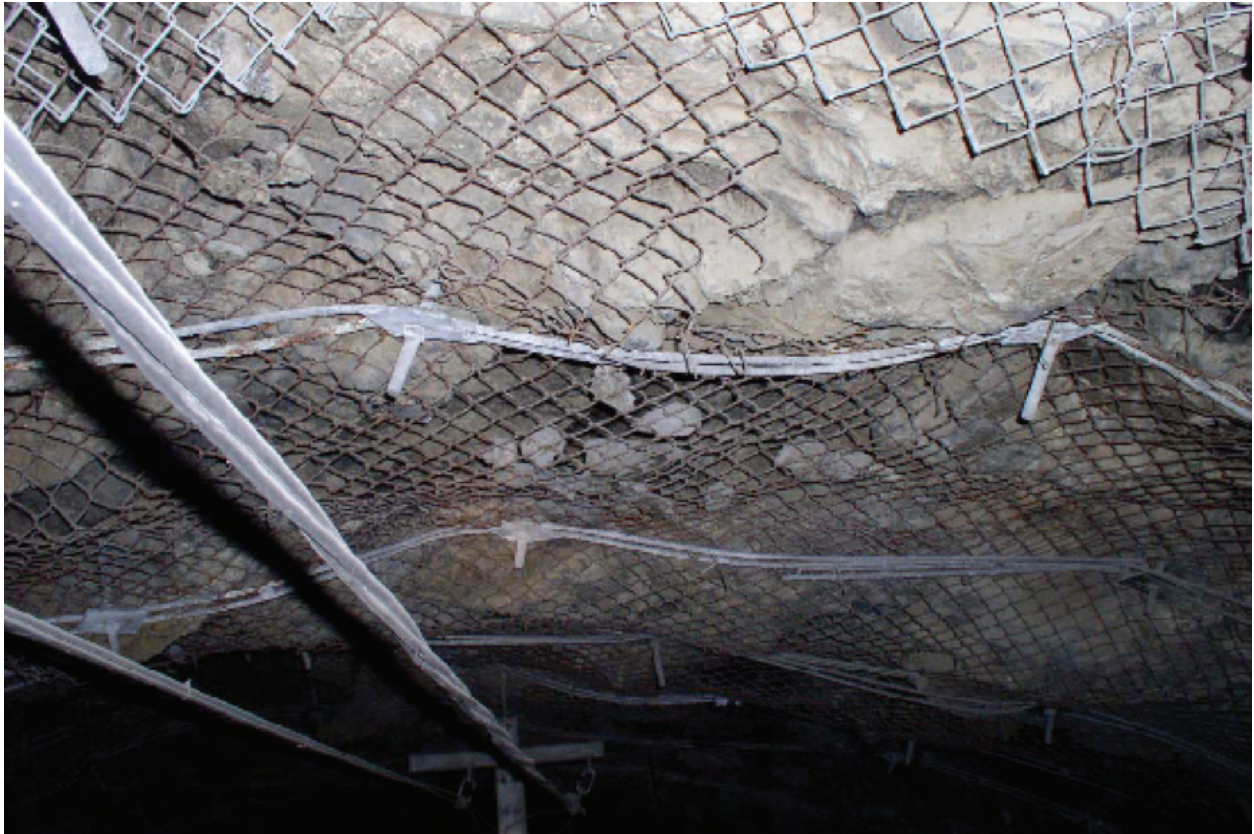
Figure 2: A 25-year-old wire mesh, completely corroded. An attempt has later been made to repair the damage using new wire mesh and steel straps.

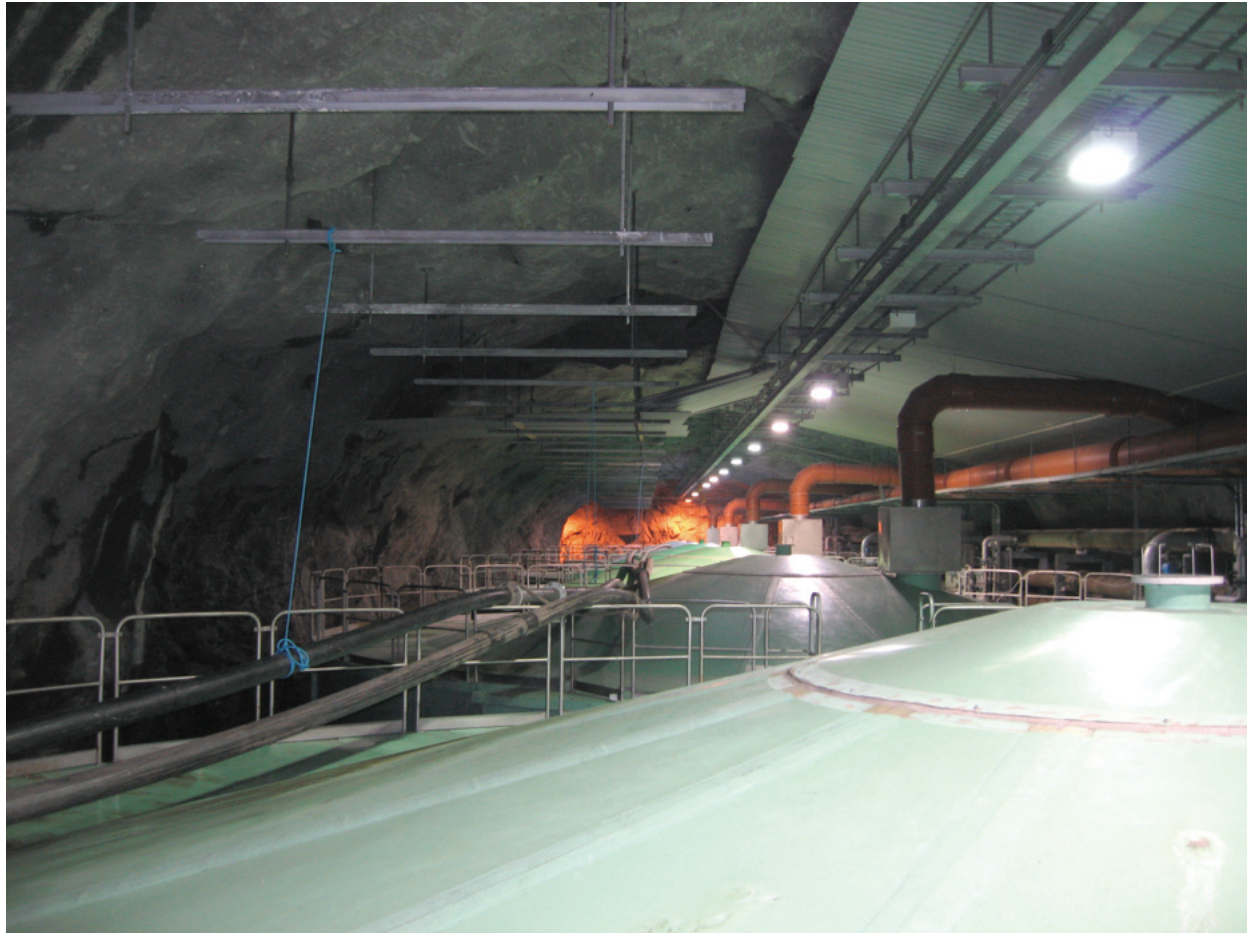
*From waste water treatment plant near Oslo with limited access for repair or improvement of rock support.*

Underground caverns. In case of vulnerable installations in a cavern like water treatment plants or hydropower stations, repair has to be carried out very carefully with protection of the installations during the work. Because of the installations the access to the periphery of the caverns is often limited. Scaling of loose rock or concrete slabs is normally out of question in such cases. In stead of scaling, mesh may be installed, fixed to rock bolts or combined with sprayed concrete in order to avoid falling rock. Spraying of concrete is also difficult because of dust and rebound from the spraying may destroy installations. In this case all installations have to be covered or temporary removed before spraying.

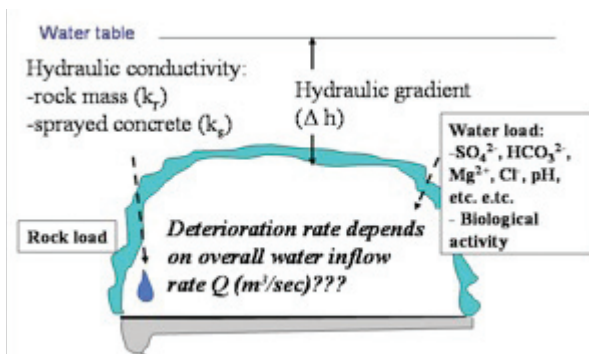
Figure 1: Principal aspects of environmental loads acting on sprayed concrete in tunnels.

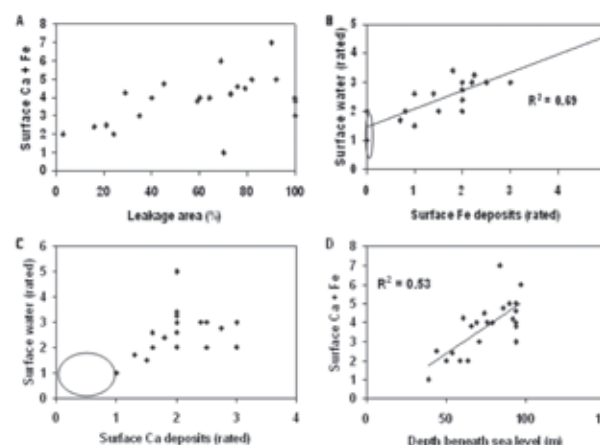
Figure 4: Surface deposits of iron ± manganese (Fe) and Calcite (Ca) show positive correlation with leaching area (A); local surface waters (B, C) and hydraulic gradient (D). Data from the Flekkerøy subsea tunnel. Ellipses represent variation in the fresh water sections under land.

These results prove that concrete deterioration in the subsea environment depends on the hydro geological lay out; the effects of chemical deterioration are not solely depending on the NS EN-206-1 exposure classes but indeed also on the hydraulic gradient (driving force). Preferably future systems should be incorporating these effects as a better basis for planning, exposure classification, cost analysis and forecasting of maintenance costs.

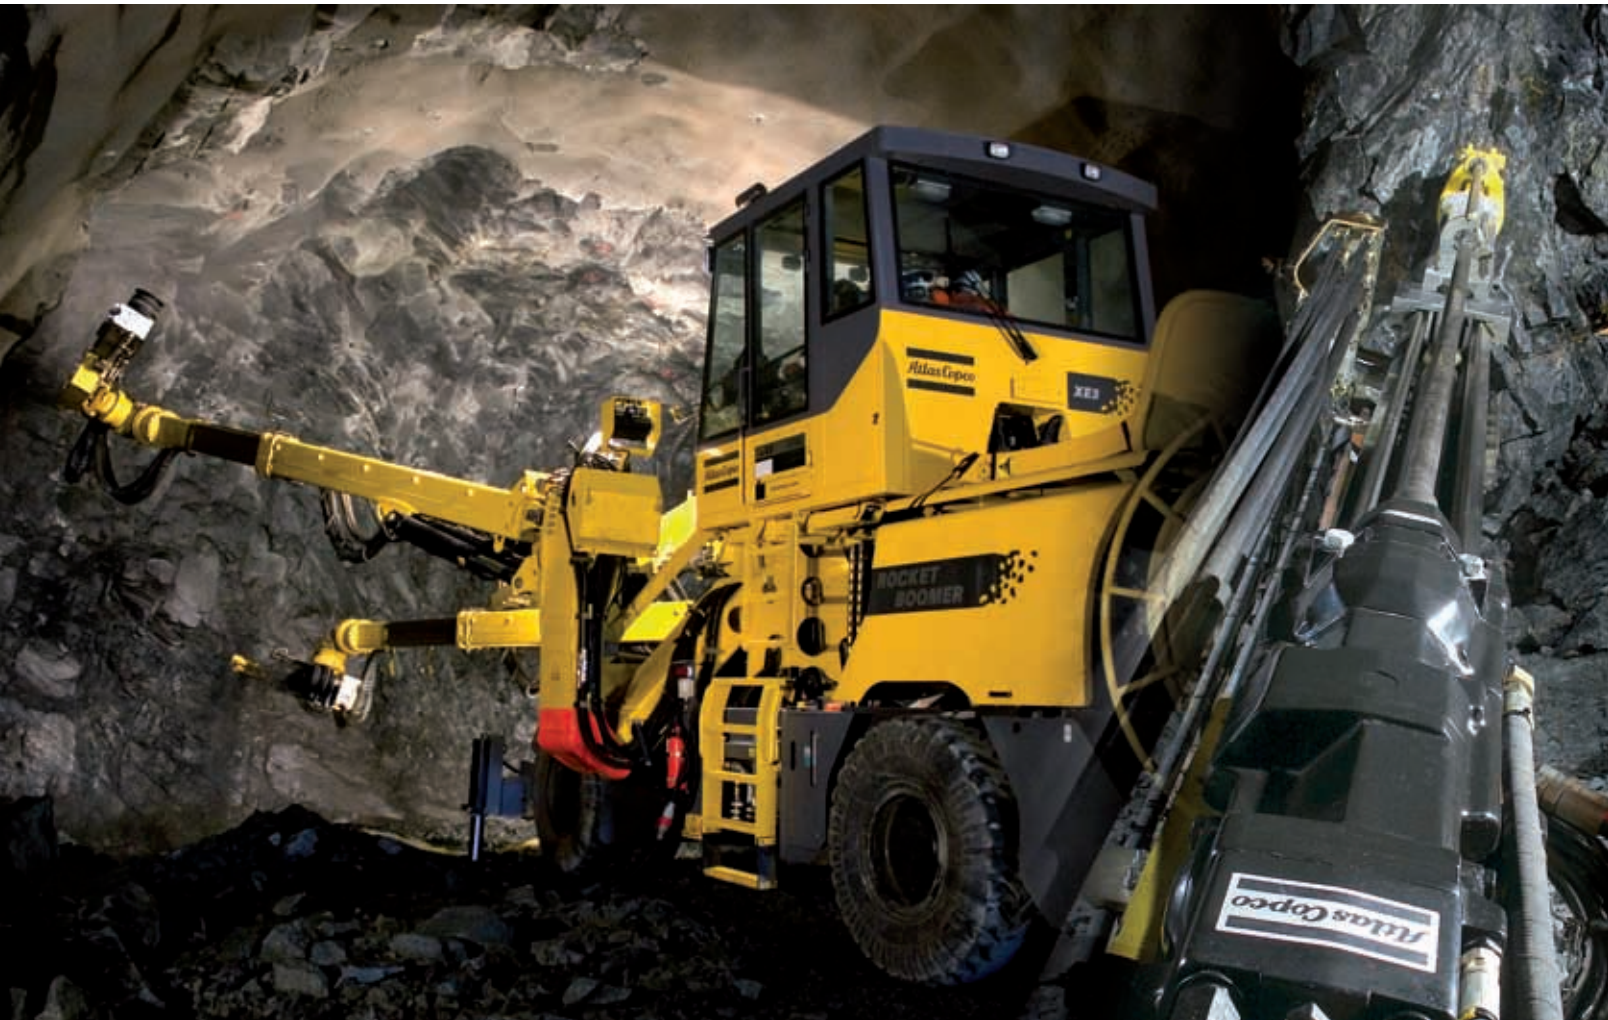
**Tunnel Manager MWD (Measure While Drilling) is an instrumentation and software for recording and interpretation of drilling data and enhanced presentation of geo-mechanical variation of rock ahead of the tunnel face.**

One of the most difficult, yet extremely important steps in drifting and tunnelling is to predict the geological and geo-mechanical variations ahead of the tunnel face, particularly in stretches where rock formations are expected to vary considerably. An advance awareness of geo-mechanical properties ahead of the face can save large amount of valuable time and money and improve safety, by allowing to take appropriate measures before reaching the difficult and dangerous formations.

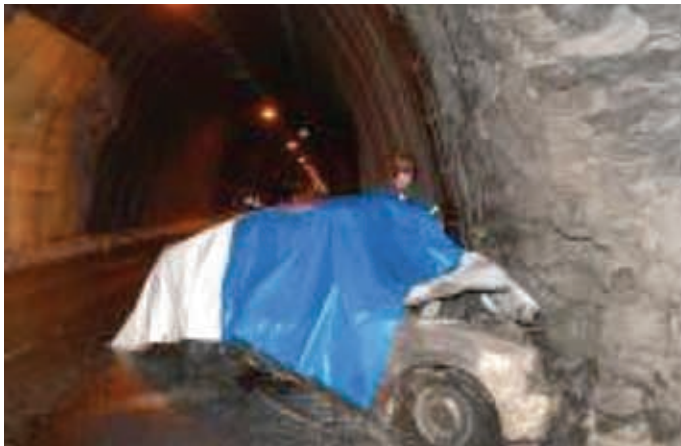
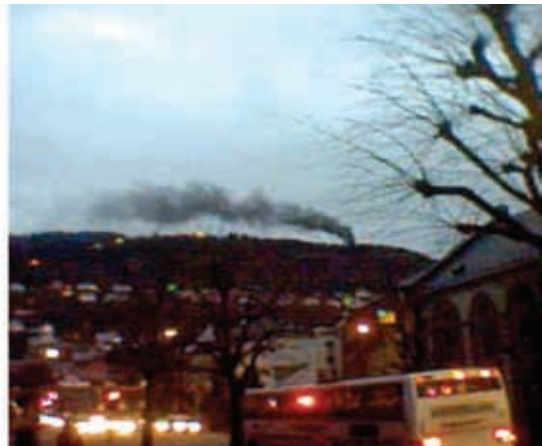
*Left: The wrecked car. The driver was killed. No passengers in the car. Right: The fire could be observed from far away.*

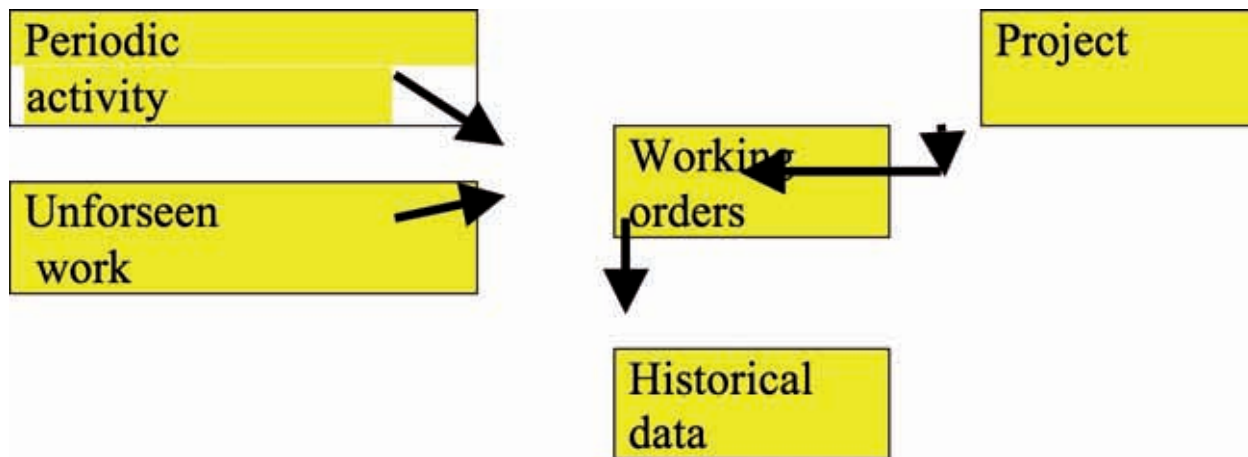
Above is a process illustration. Detailed instructions are part of a maintenance contract. Template work orders for the periodic activities are downloaded from the AOM program. Observations and registration during the execution is reported back and will eventually be included in the "historical data".

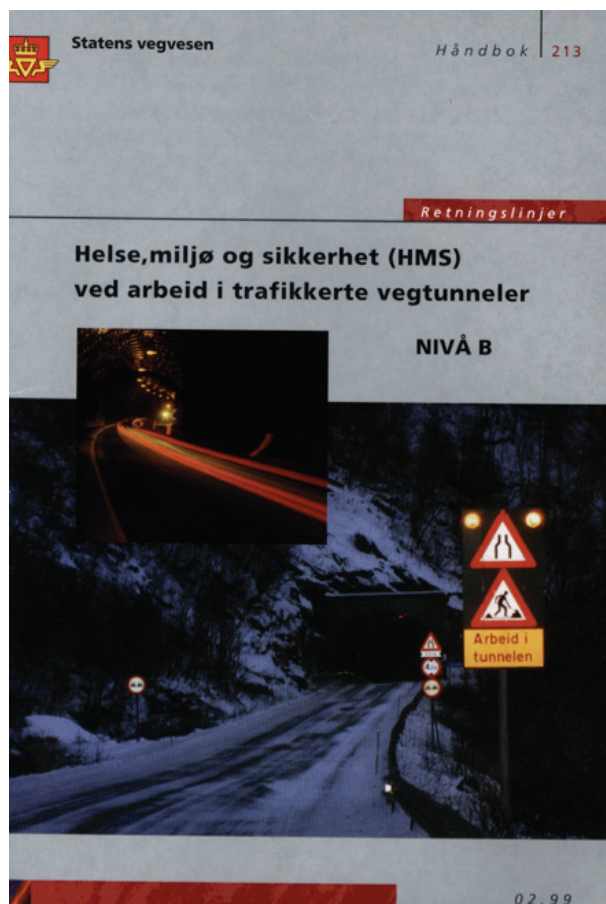
Front page of Handbook with guidelines for HES while working in road tunnels

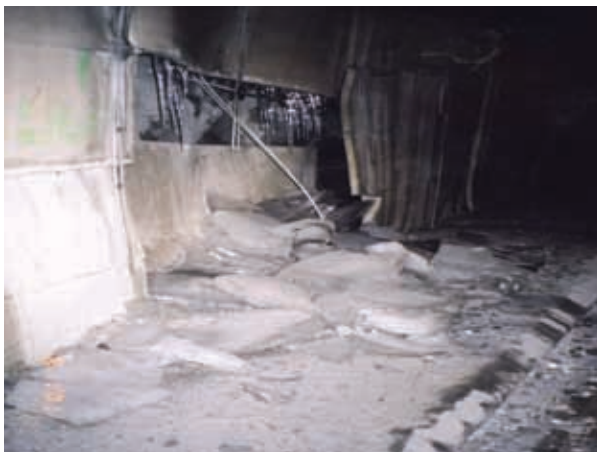
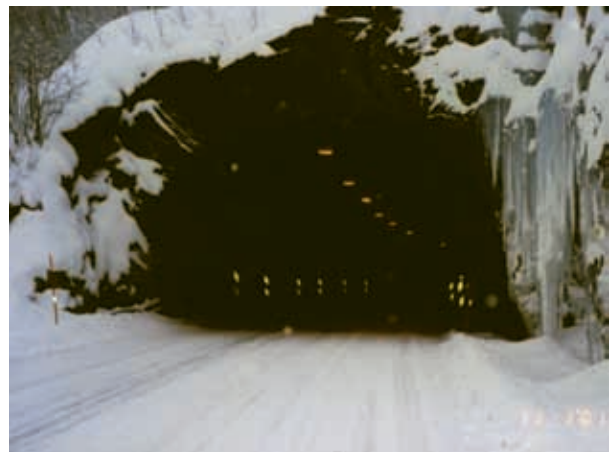
*Efficient winter maintenance is based on the use of high capacity equipment. Access is a prerequisite.*

*Any snow in the tunnel should be removed with a grader, plow, blower or tractor.*

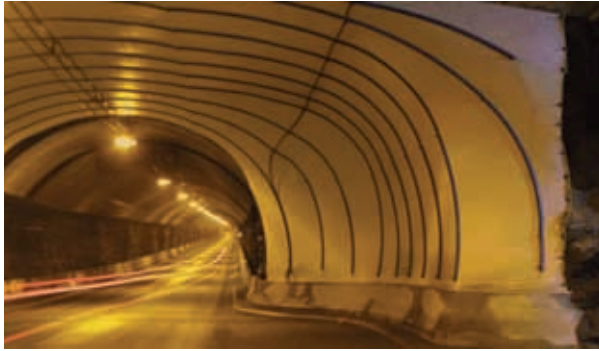
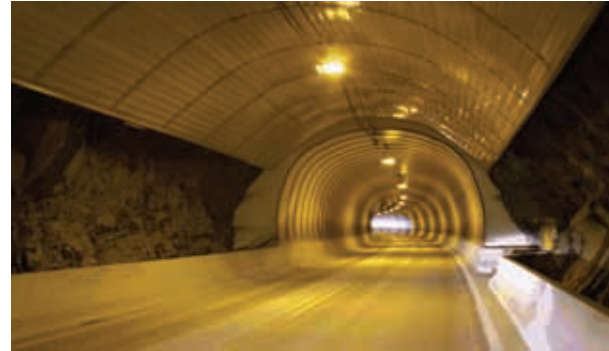
Wall surfaces should be easy to clean, while providing a pleasant impression

The lower part of the walls shall be designed to withstand a car crash without being damaged. This part of the walls shall be 0,95 and 3,50 metres high in low density and high density traffic tunnels respectively.

Concrete elements or bricks of New Jersey type with white cement and aggregates should be used. Advantages achieved are:

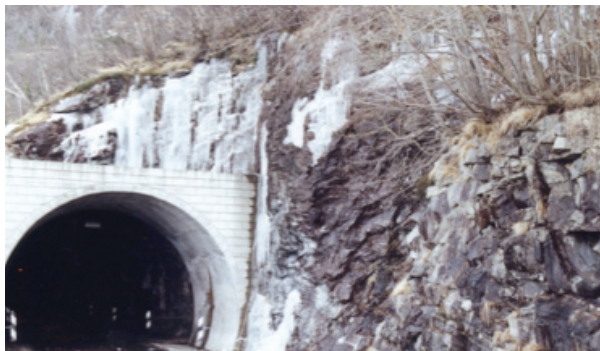
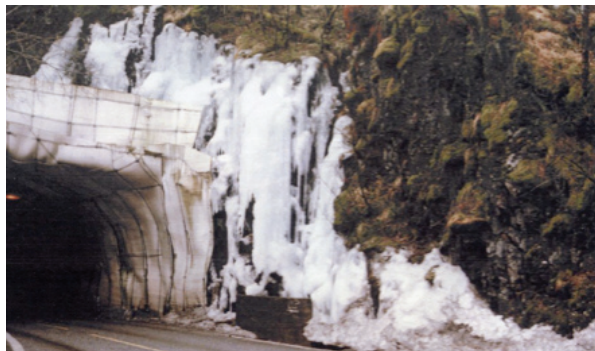
The left side portal is well designed, whereas the right side structure gives the impression of a simple makeshift set up. Both structures, however, is designed to stop incidental blockfall of ice and rocks, water leakages and landslides at the entrance of the tunnel
