Erfaringer med sprengning nær kvikkleire (Experiences with blasting near quick clay: vibration and pore pressure monitoring)

10 Mai, 2022

NFFs 33.e teknisk sprengningskurs

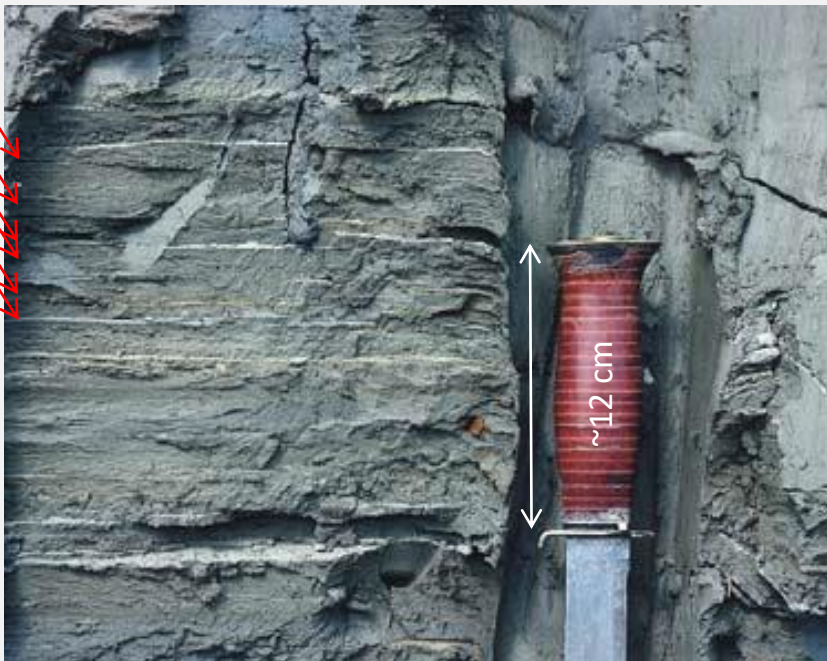
Quick clay with thin silt layers

1-2cm clay layers? Silt, fine sand 1-3 mm?

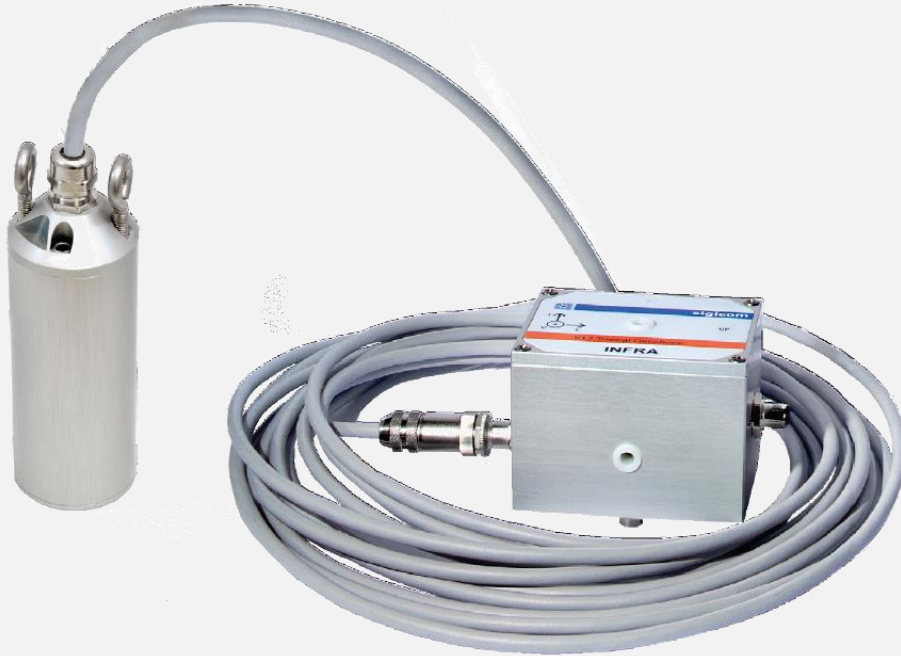
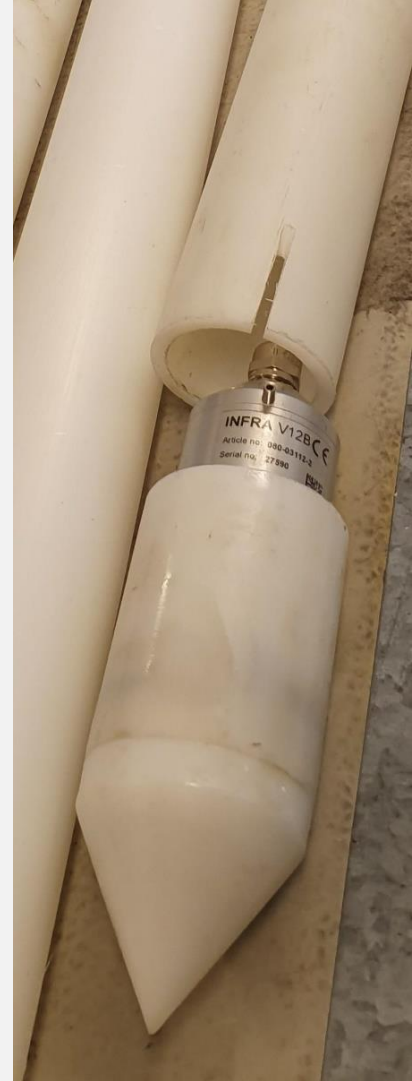
Installation of geophone in clay

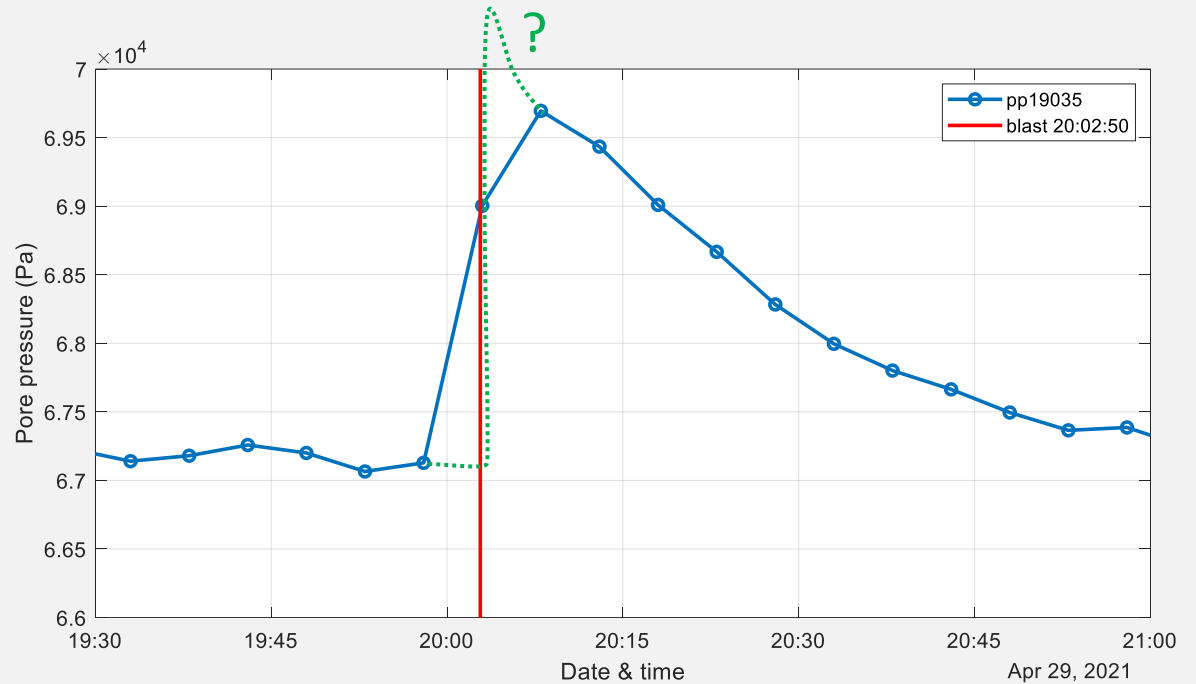
Pore pressure blast 9

- Piezometer 19035 @10 m depth.
- Pressure around 67 kPa, Increase ~2.5 kPa
- Vibrations ~40-60 mm/s at 5 m depth and 30-40 mm/s at 3.5 m depth
- Cyclic strain 0.05-0.1 % (?) at 3,5-5 m depth

Time	Strain (%) @3,5m depth	Strain (%) @5,0m depth	Pore Pressure change (kPa) @10 m depth	Pore pressure Ratio u/σ'_v
14:46:36	0.02	0.01	~0.8	2%
20:02:50	0.03 (0.07%)	0.02 (0.08%)	2.6	6%

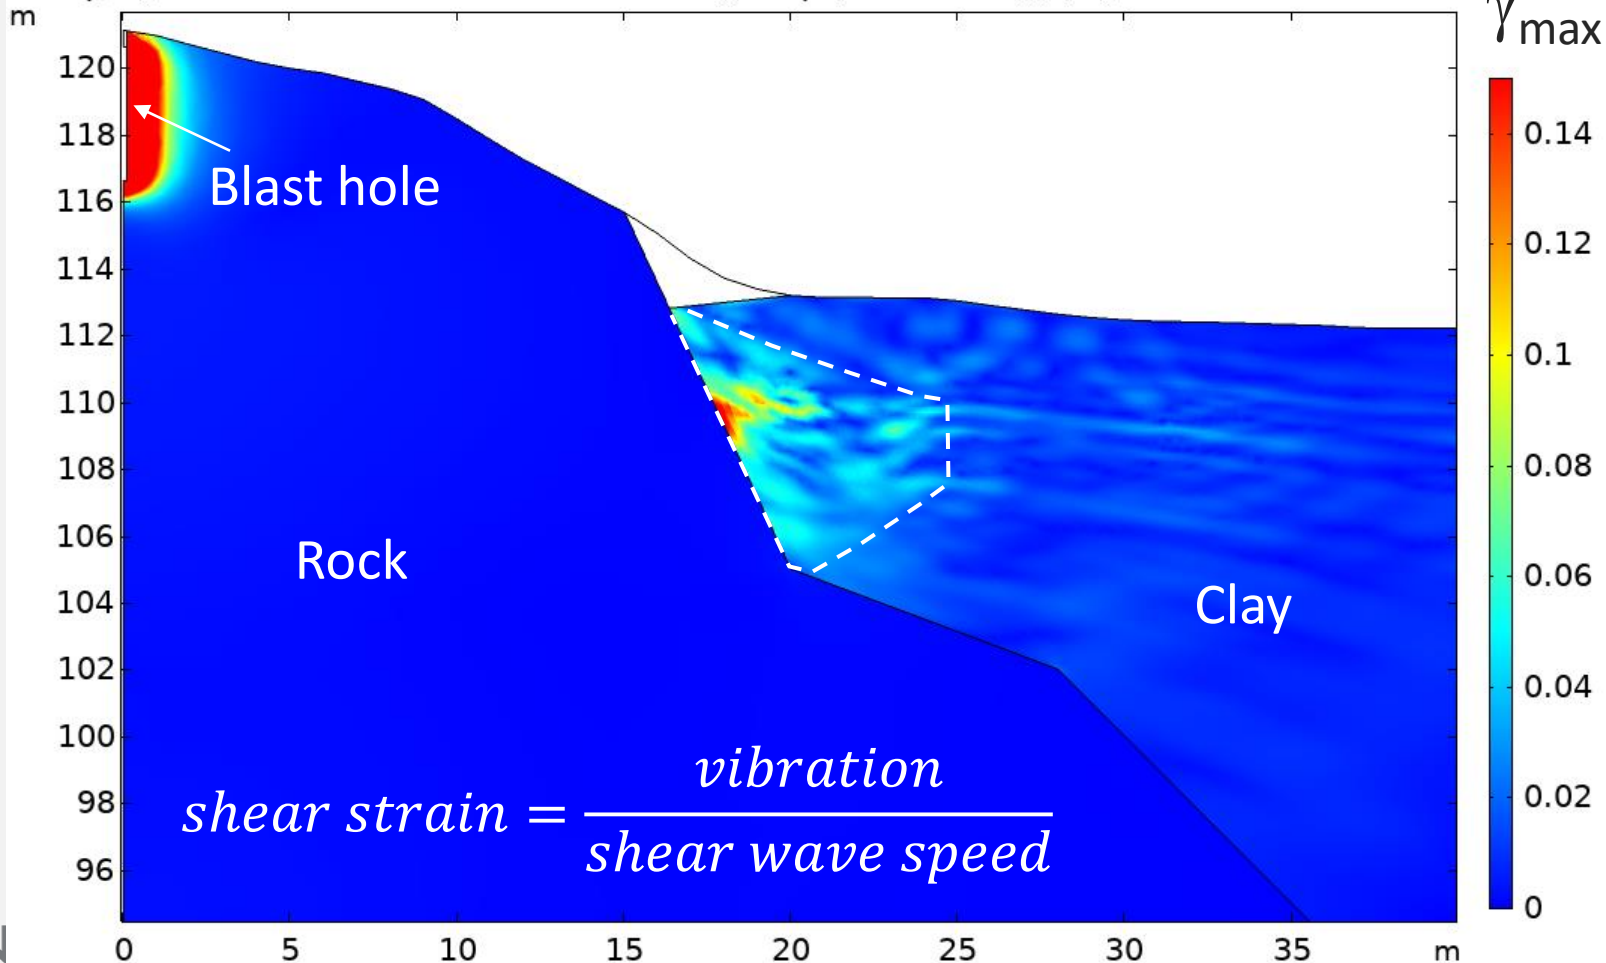
Numerical modelling

freq(43)=52 Hz

Surface: abs((2*sqrt(solid.II2eel))) (%)

- Based on numerical analysis to evaluate stress and strains and contour diagrams for pore pressure build up for Silt.
- Pore pressure diagram has for quick clay recently been established.
- Pore pressure in relative good agreement with measured values.
- $G_{\max}=18 \text{ MPa}$, $G/G_{\max}=0.5$, $\gamma=0.05\%$ give $\tau_{cy}=5 \text{ kPa}$

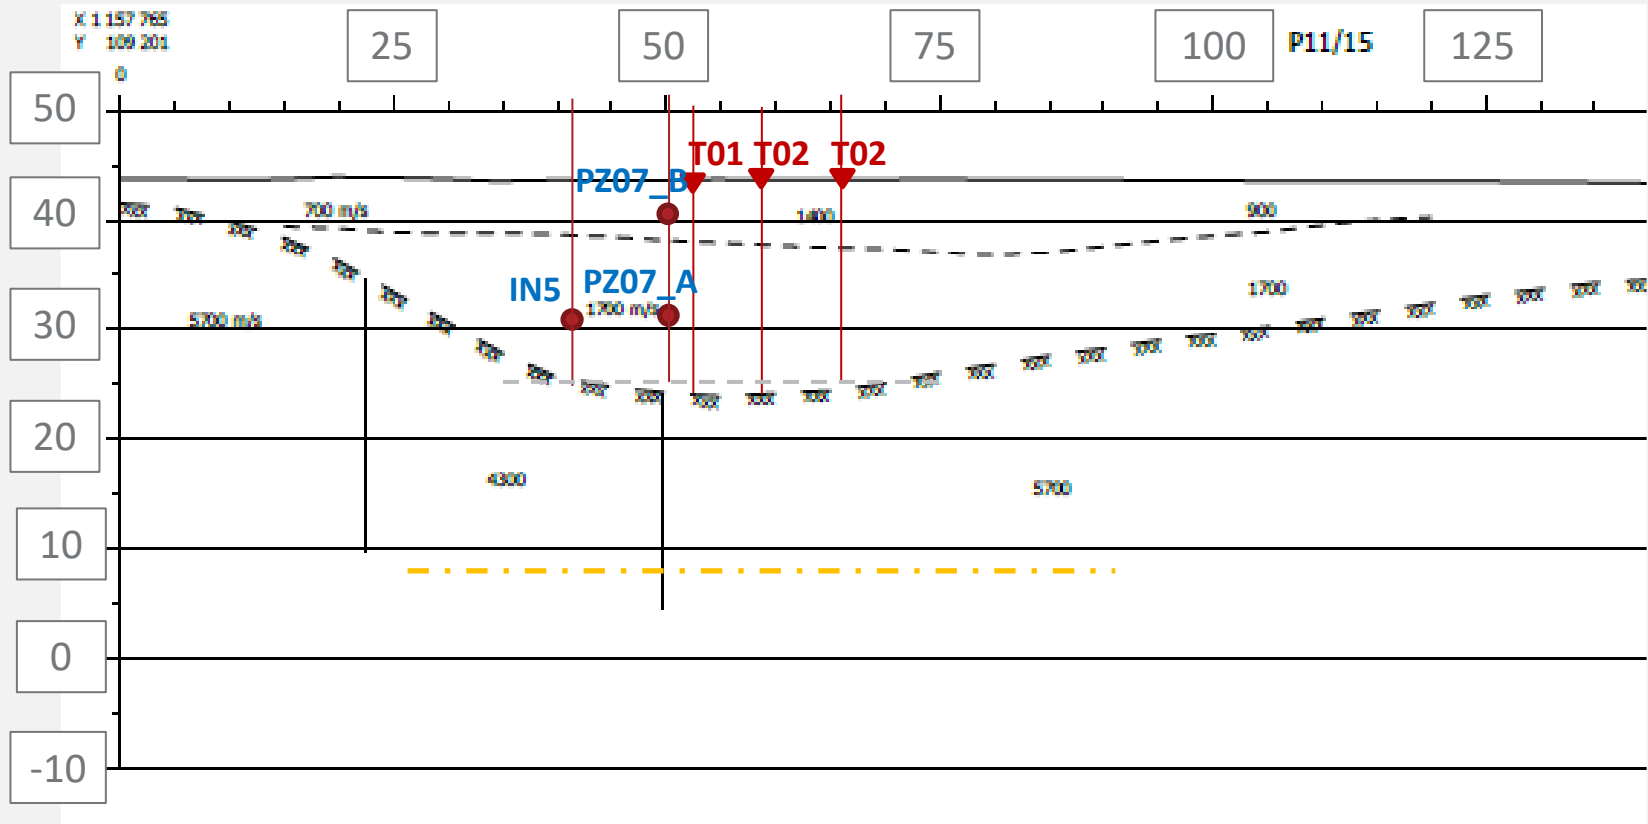
Seismic profile with locations of sensors

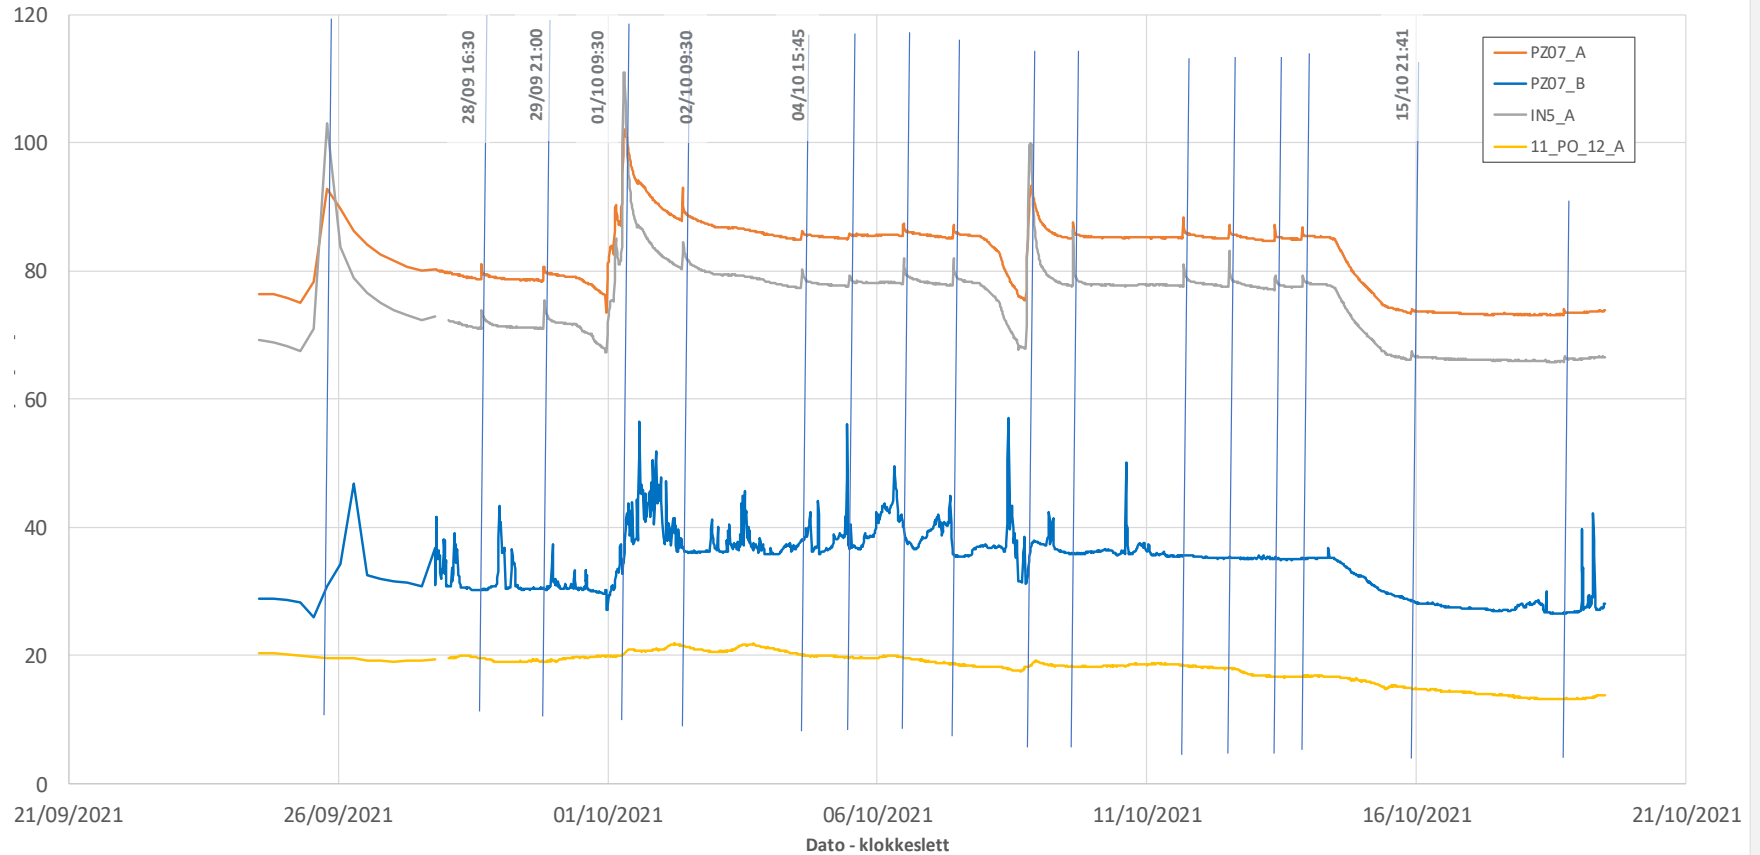
Pore pressures

Pore pressure (kPa)

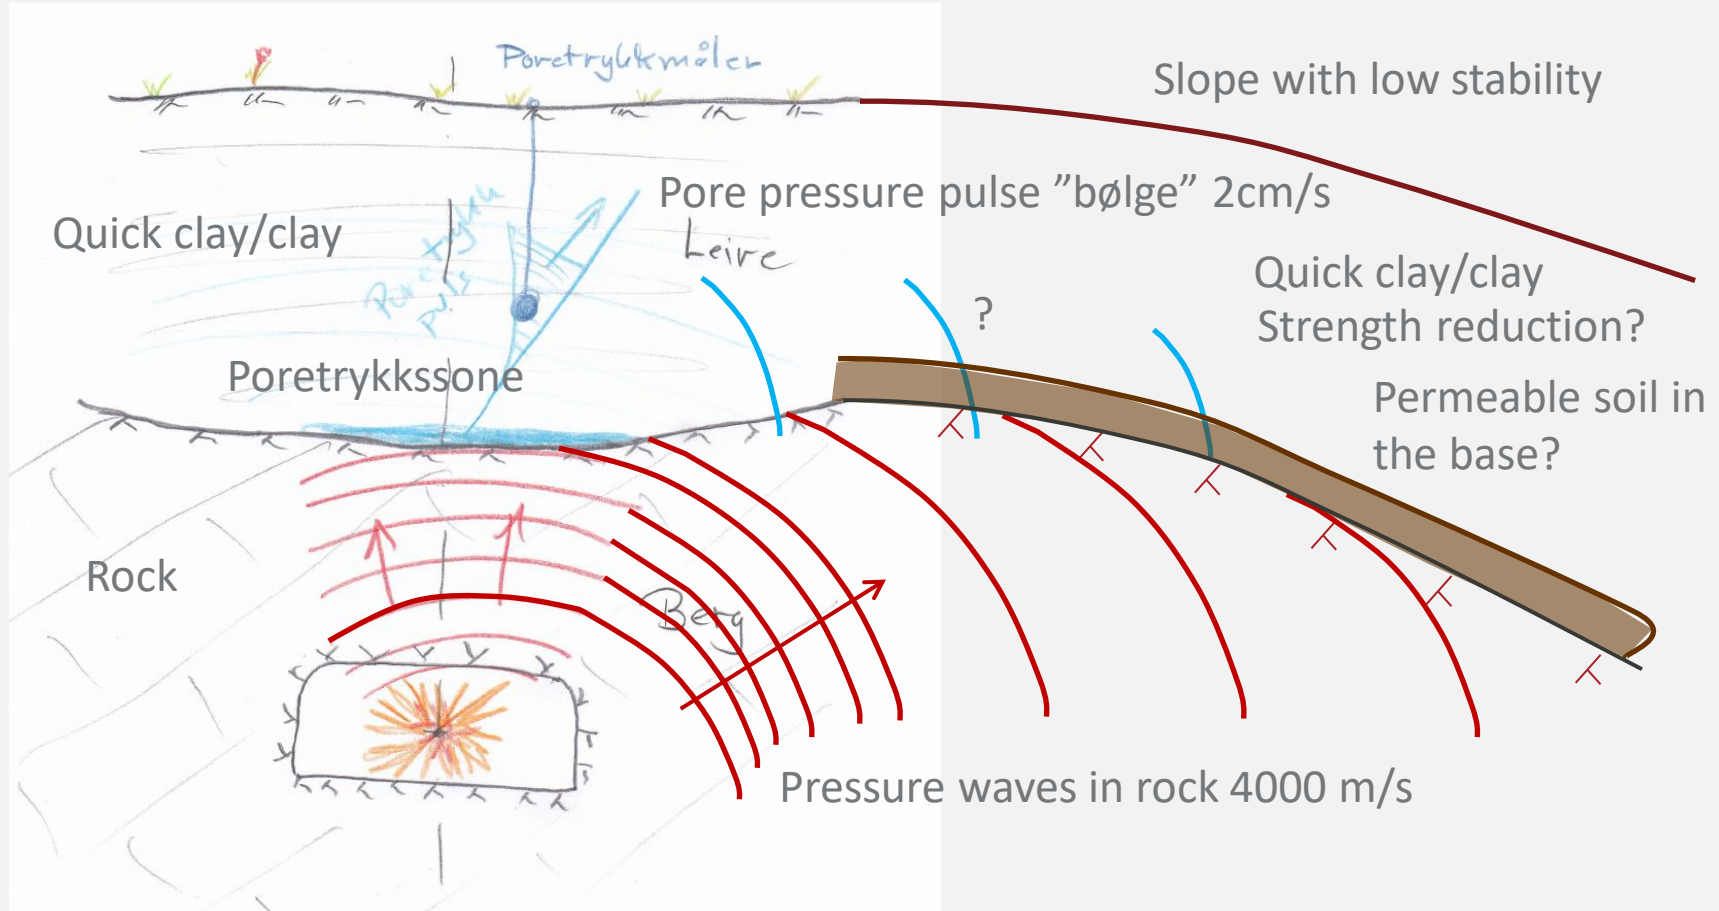
Sketch of blast induced pore pressure and propagation

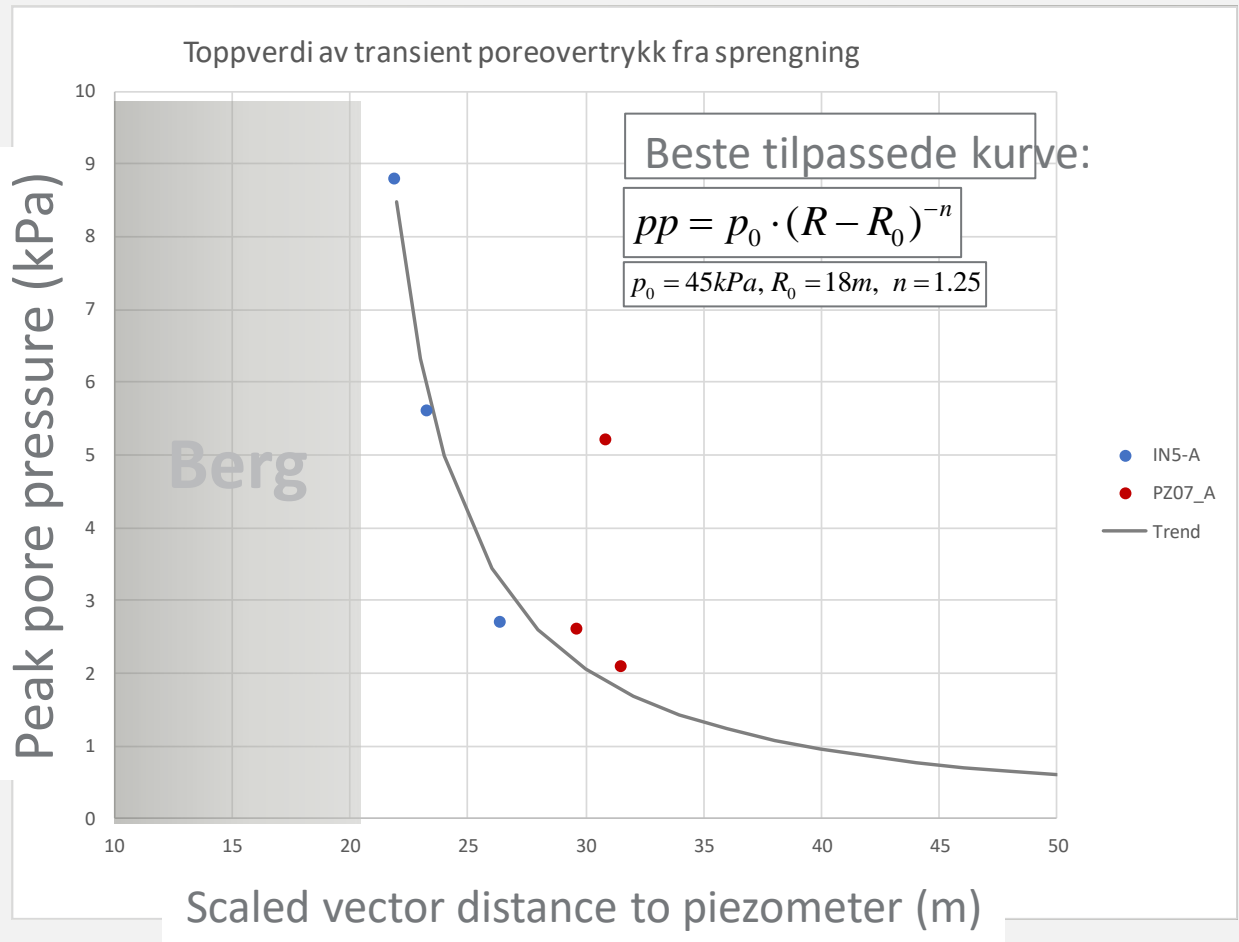
Transient pore pressure peak value vs. distance

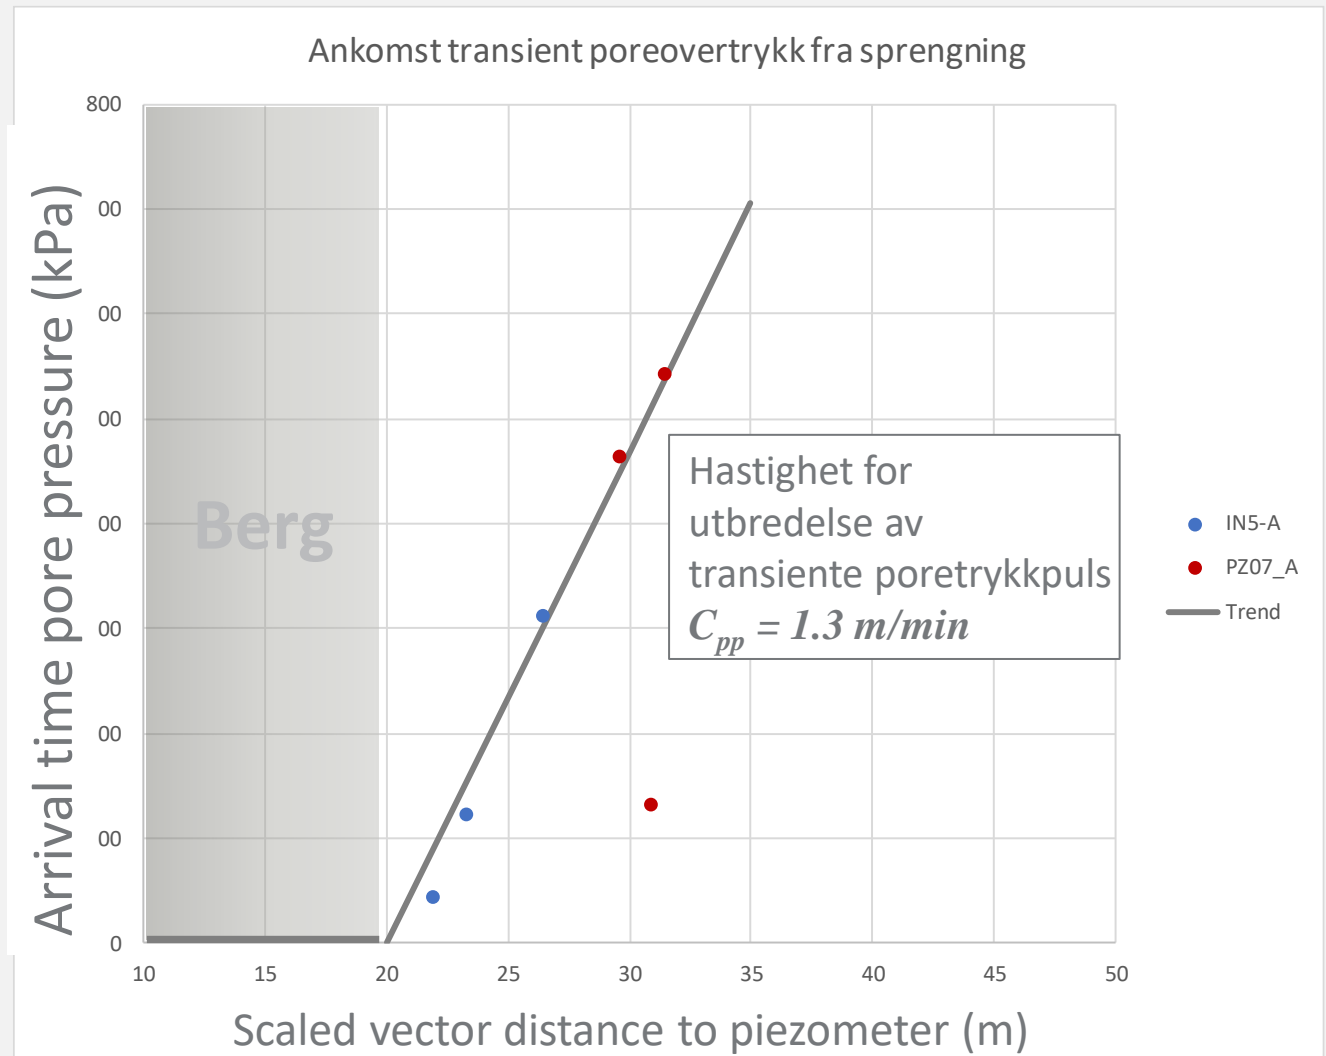
Arrival times pore pressure

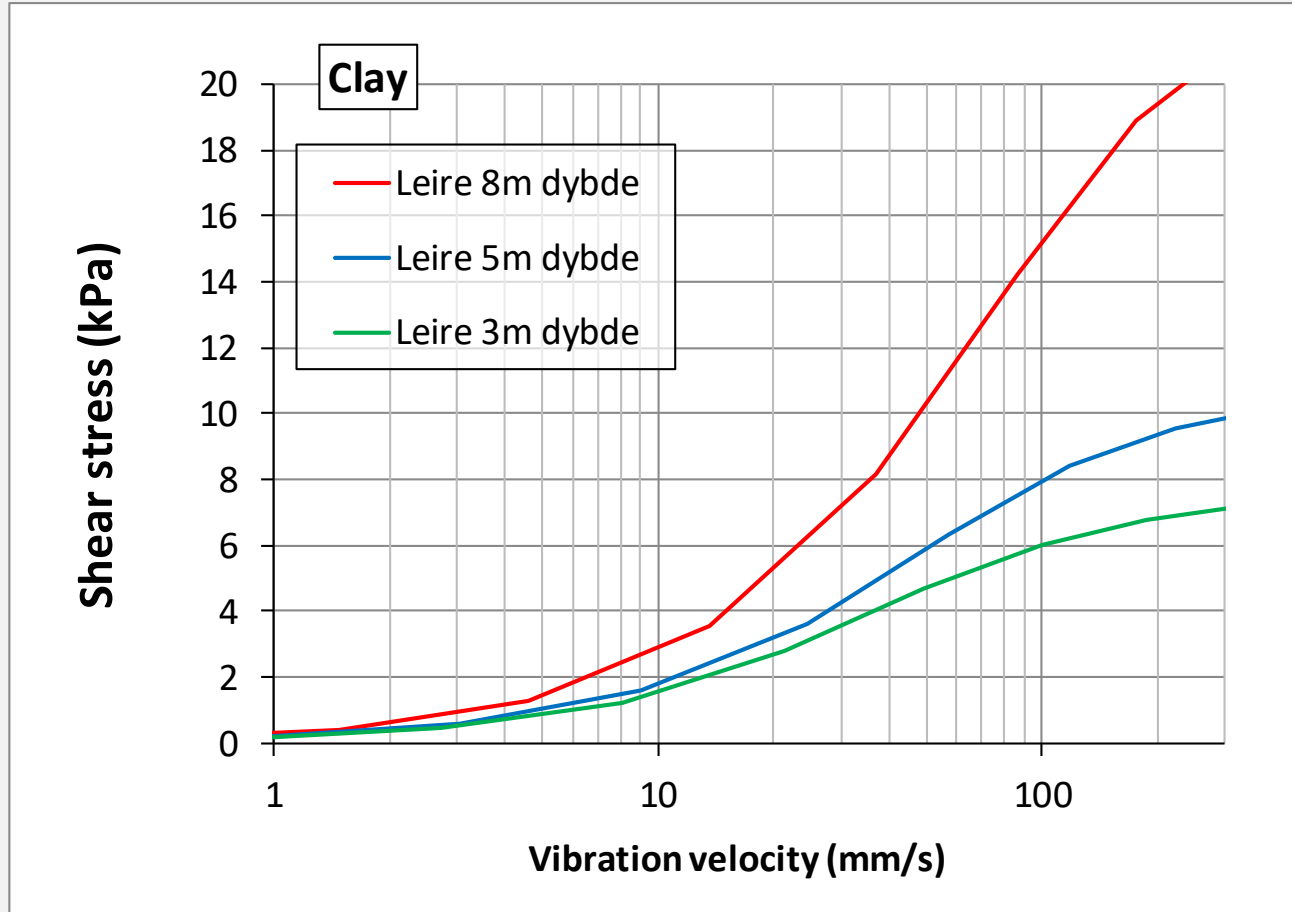
Relation between cyclic shear stress and vibration velocity

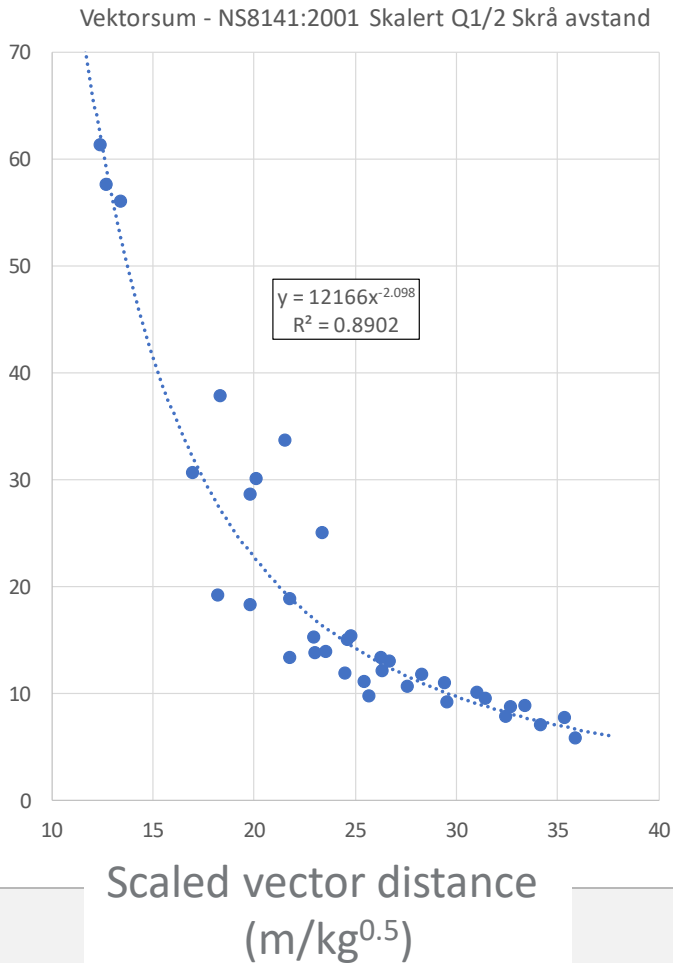
Vibration amplitude vs. scaled distances

Vector sum top value

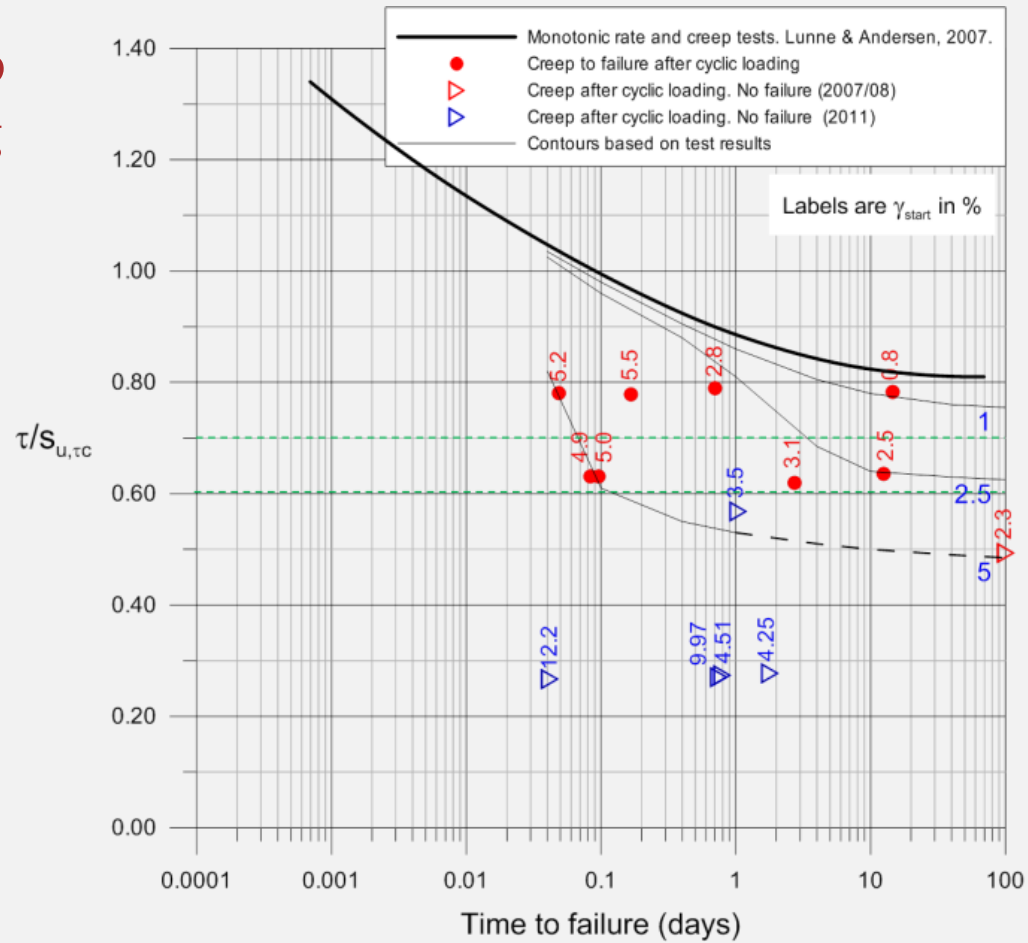
Contour diagram for creep failure after cyclic loading

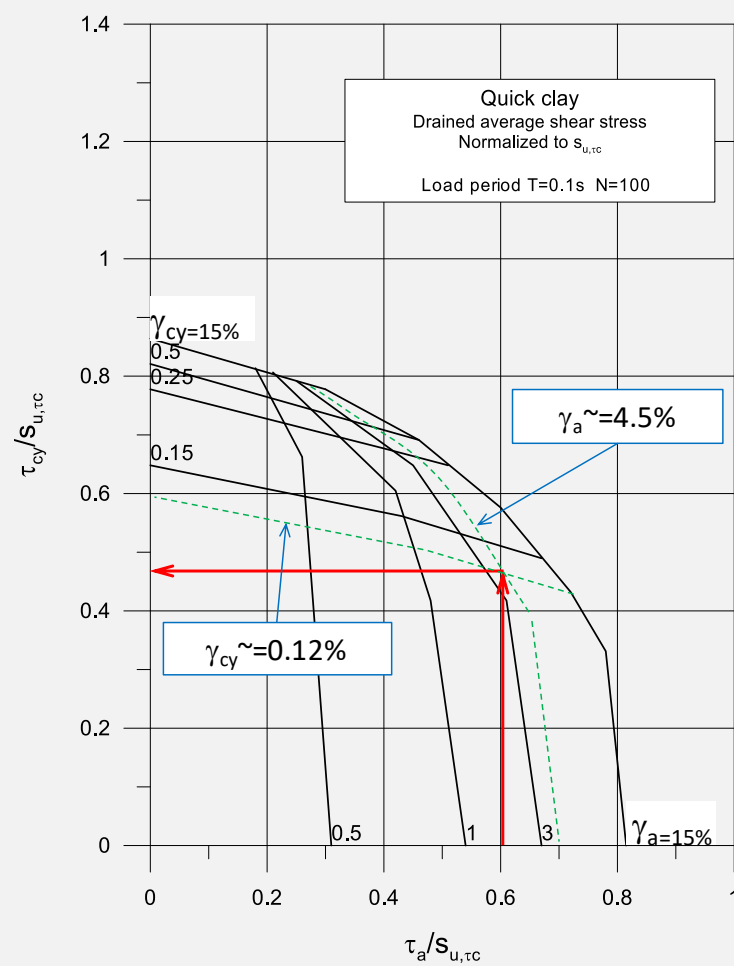
Contour diagram for N=100 cycles and load period of 0.1s (10Hz)

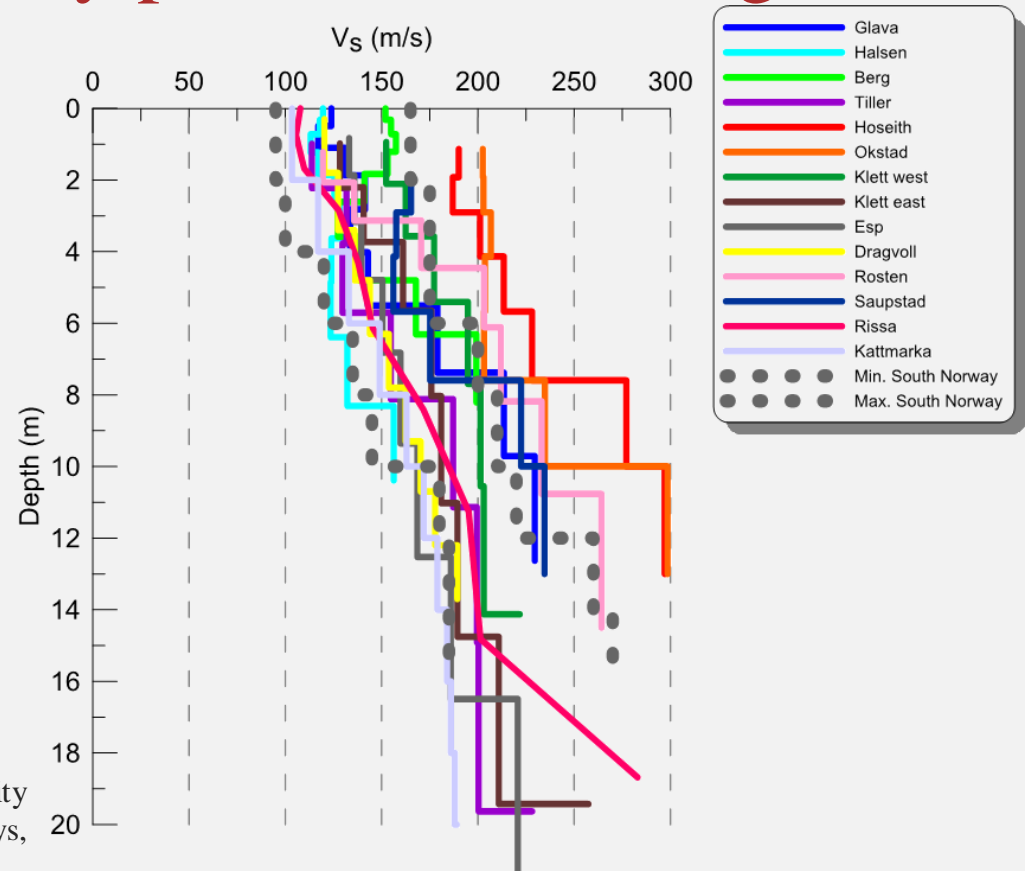
In situ shear wave velocity profile for Norwegian sites

NGI, SP8-GEODIP, Correlations between shear wave velocity and geotechnical parameters in Norwegian clays, 20150030-04-R, 2015-11-02.

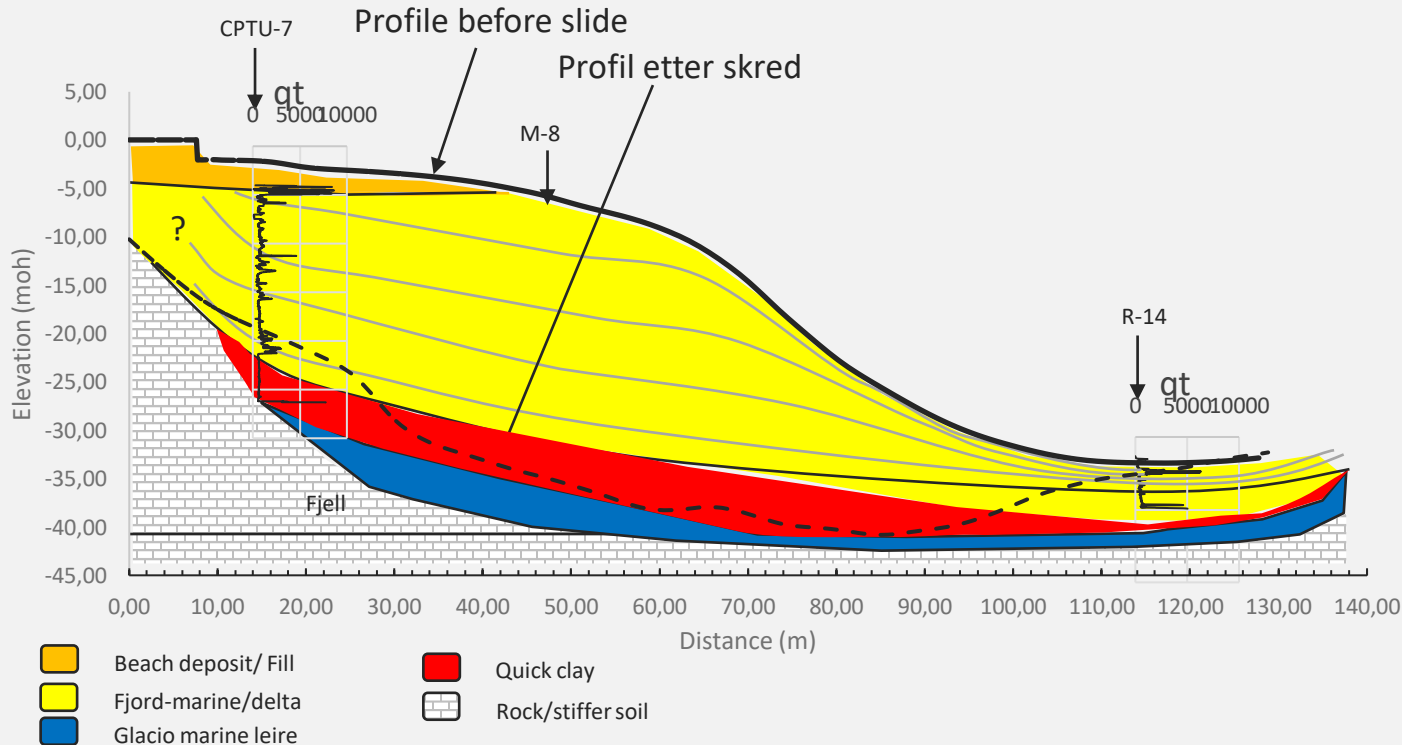
Example of near shore soil profile

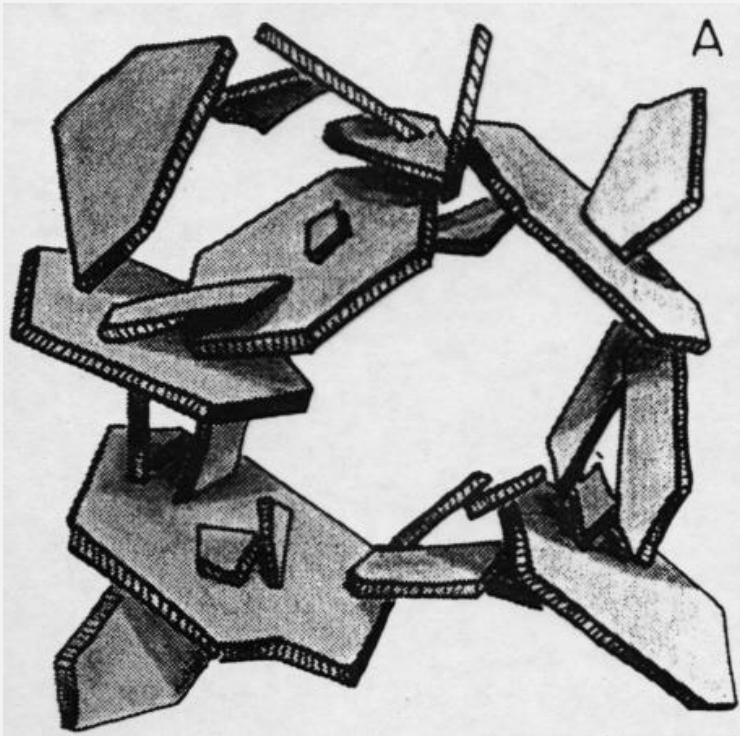
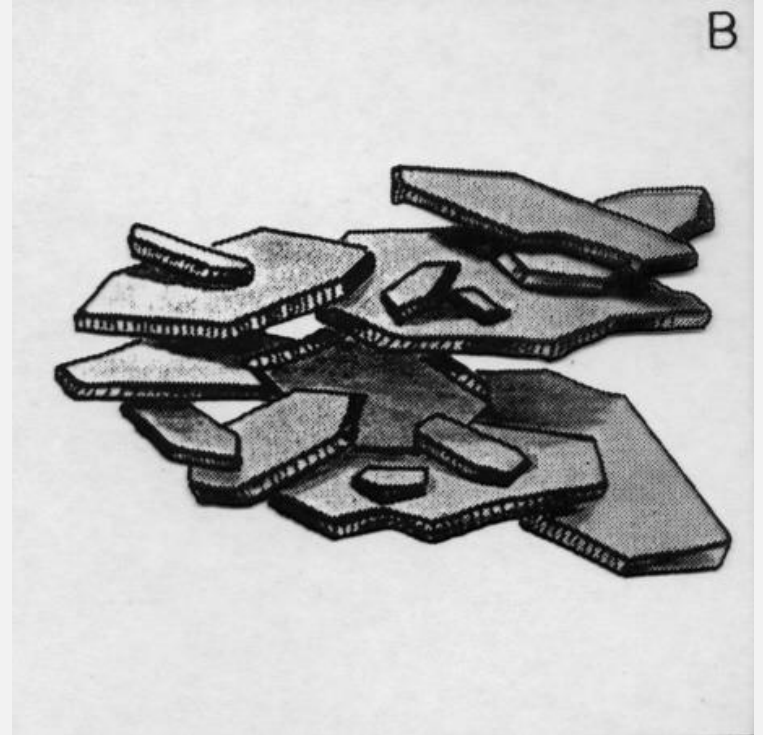
Salt ions contribute to electric bonding and open structure of marine clays

The structure can easily collapse when salt ions are removed

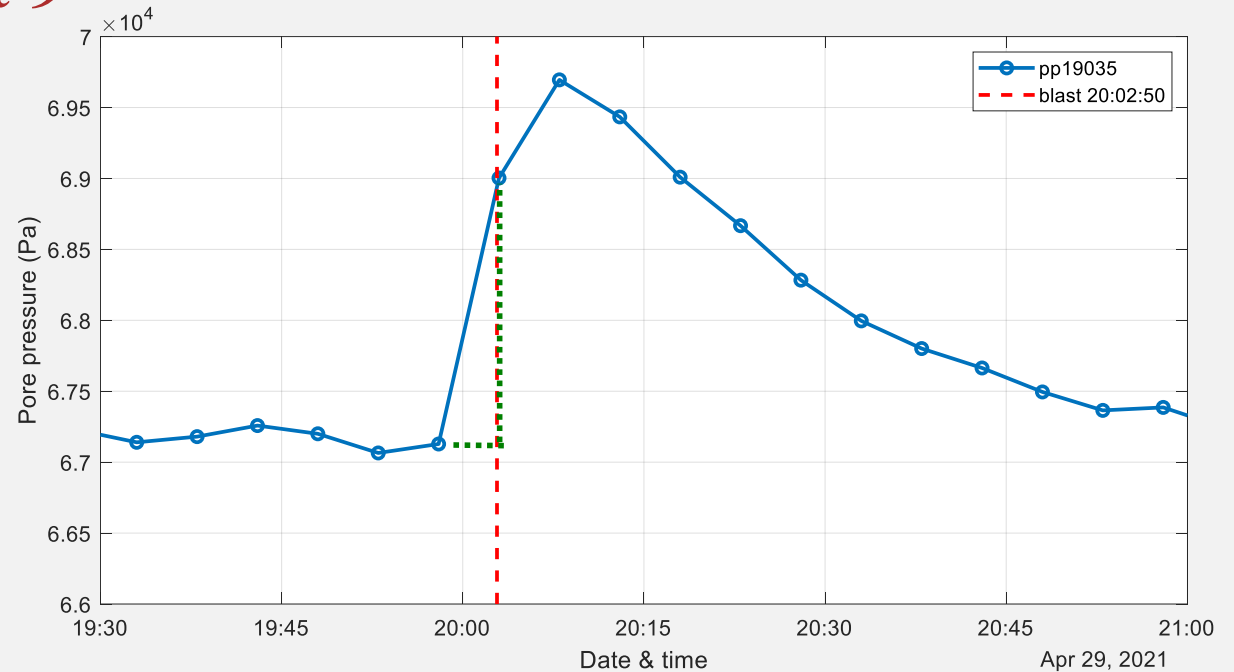
Pore pressure blast 9

- Piezometer 19035 @10 m depth.
- Pressure around 67 kPa, Increase ~2.5 kPa
- Vibrations ~40-60 mm/s at 5 m depth and 30-40 mm/s at 3.5 m depth
- Cyclic strain 0.05-0.1 % (?) at 3,5-5 m depth

Time	Strain (%) @3,5m depth	Strain (%) @5,0m depth	Pore Pressure change (kPa) @10 m depth	Pore pressure Ratio u/σ_v'
14:46:36	0.02	0.01	~0.8	2%
20:02:50	0.03 (0.07%)	0.02 (0.08%)	2.6	6%

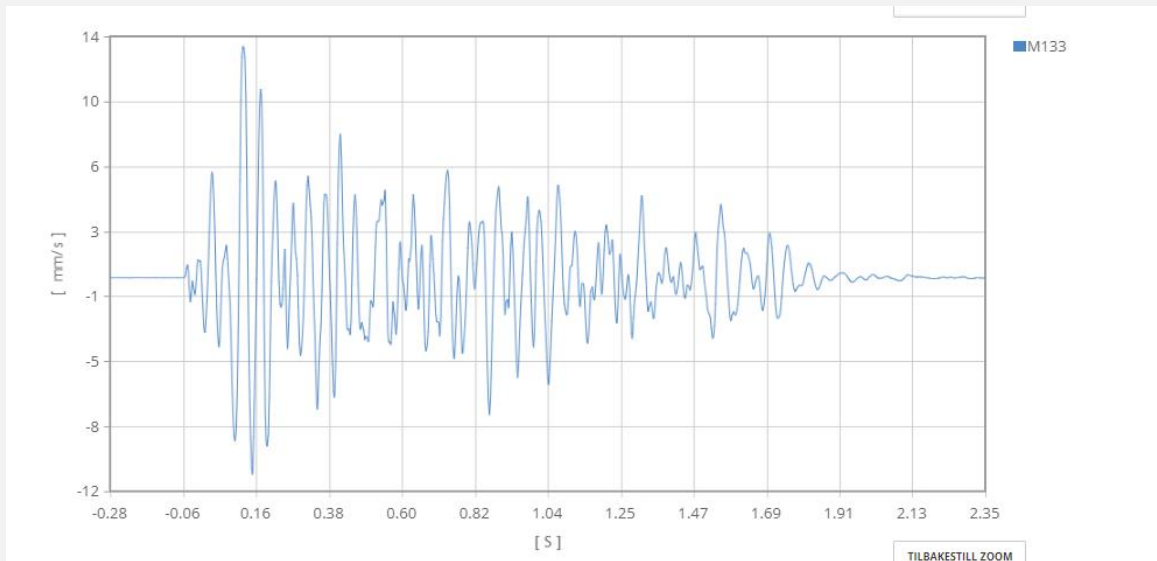
Tana vibrasjon på 100 m fra sprengning

Dato	2021-04-17 18:13:32	Instrument	Standard	5516 - 2247					
Prosjekt	50028019	Målepunkt	M133 (V10)	N58141 Byggerk					
NAVN	ADRESSE	VERDI	ACC.	FREK.	AMPLITUDE	GRENSL.	AVST.	PROSENT	HENDELSE
M135	Kulvert	1.1 mm/s * s@21.0 Hz				25.0 mm/s		52

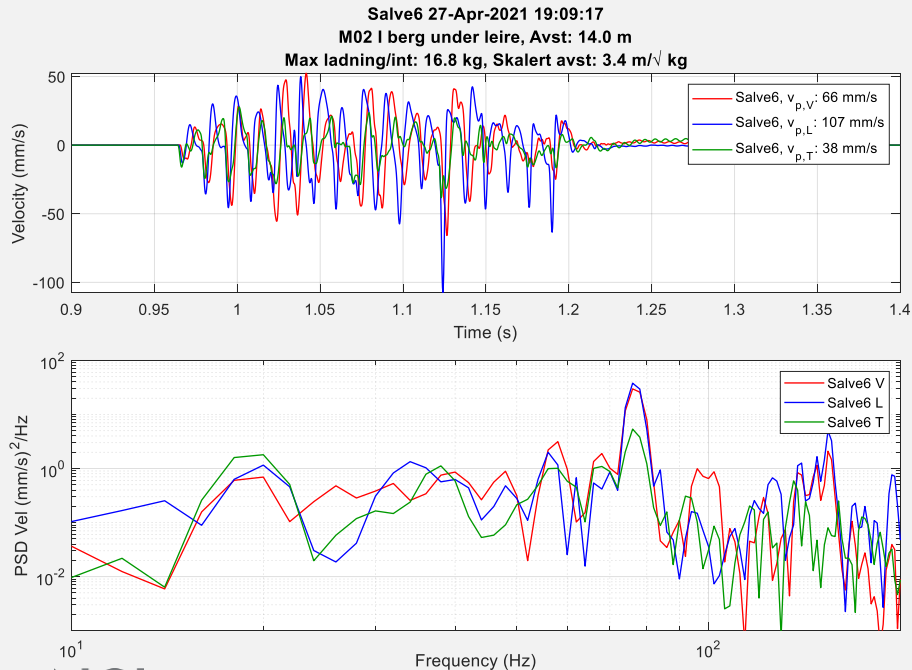
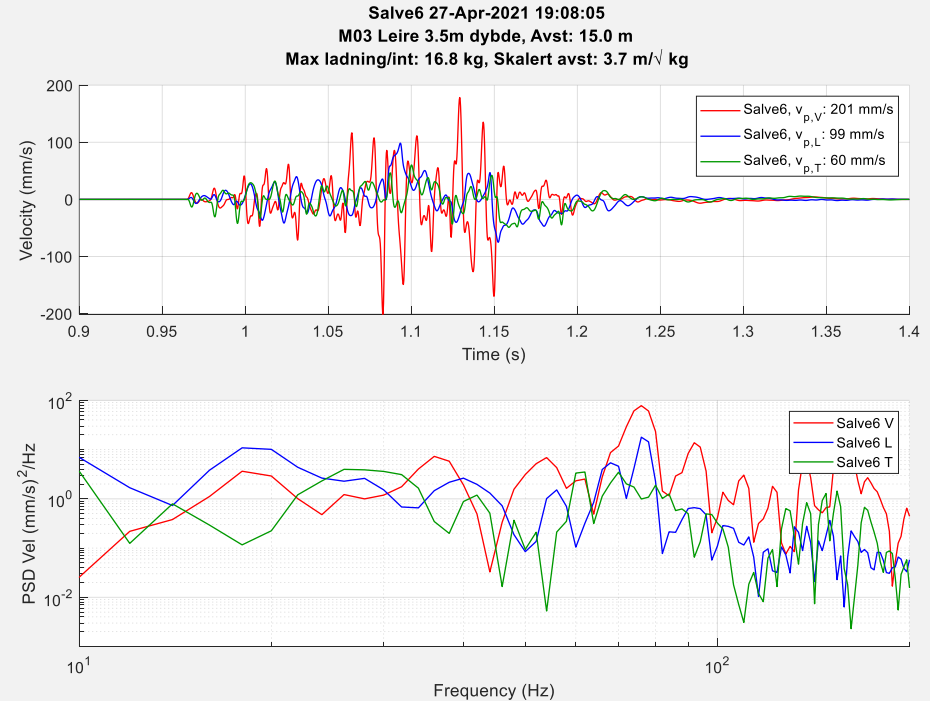
- Rock about 50 mm/s, 1 pulse 100 mm/s
- Soil 3.5 depth several cycles above 100 m/s, max 200 mm/s
- Frequency $\sim 75\text{Hz}$ (some connection to the time delay of 14 ms between charges). Still under investigation

Vibrations blast 6

- ↗ Rock about 50 mm/s, 1 pulse 100 mm/s
- ↗ Soil 3.5 depth several cycles above 100 m/s, max 200 mm/s
- ↗ Frequency $\sim 75\text{Hz}$ (some connection to the time delay of 14 ms between charges). Still under investigation

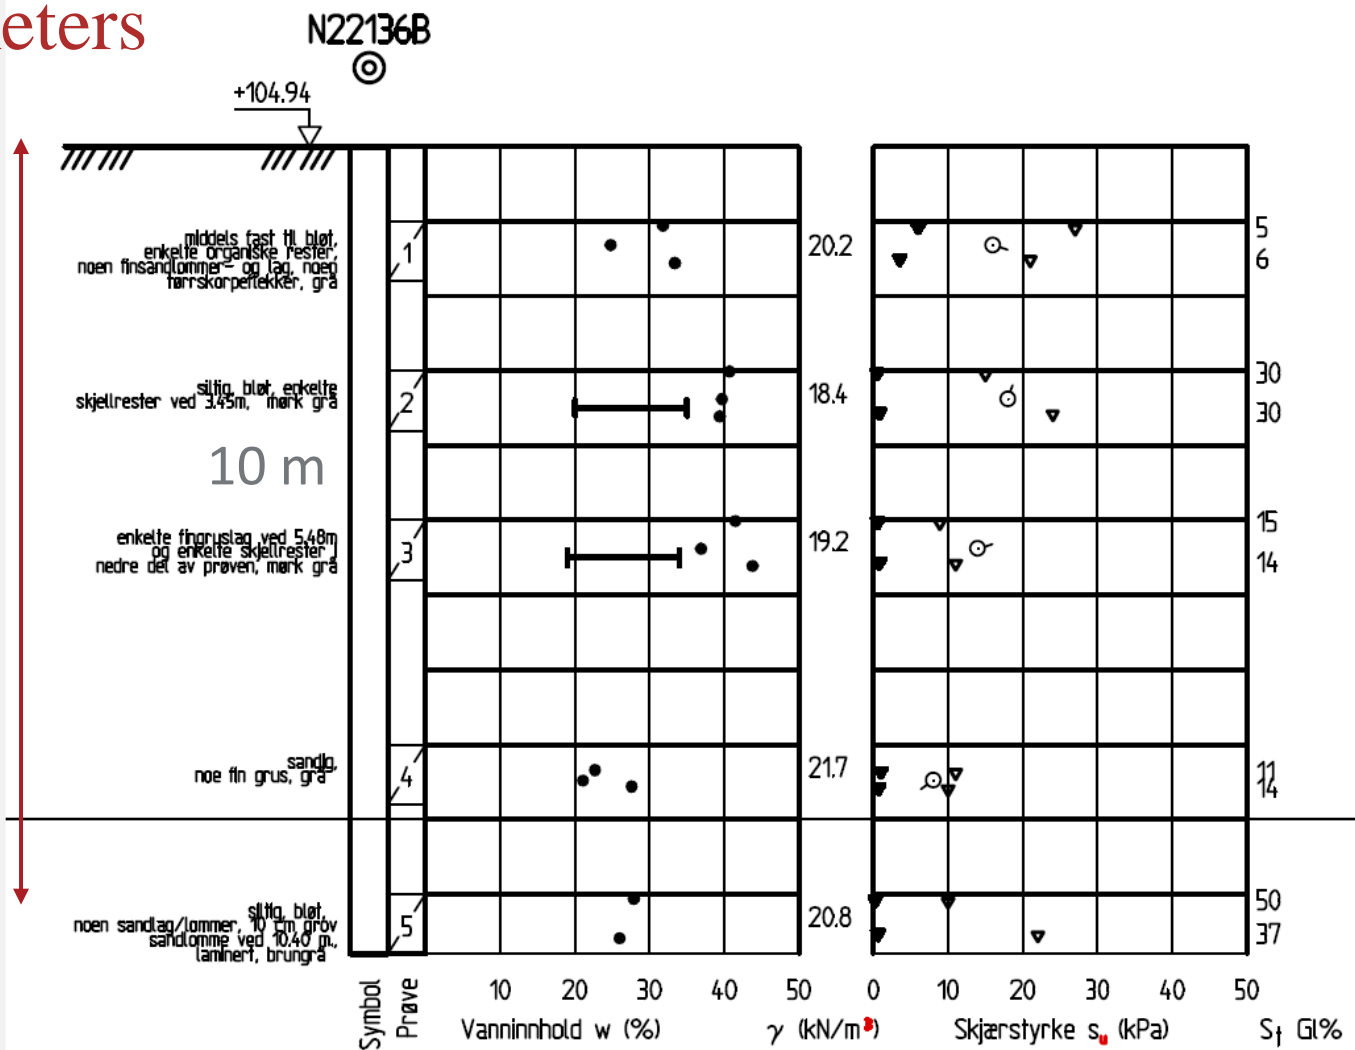
Soil properties

Soil index parameters

- PI=15%
- OCR=1.3
- Rho=19 ton/m³
- Water content 40%
