Erfaringer med sprengning nær kvikkleire (Experiences with blasting near quick clay: vibration and pore pressure monitoring)

10 Mai, 2022

NFFs 33.e teknisk sprengningskurs

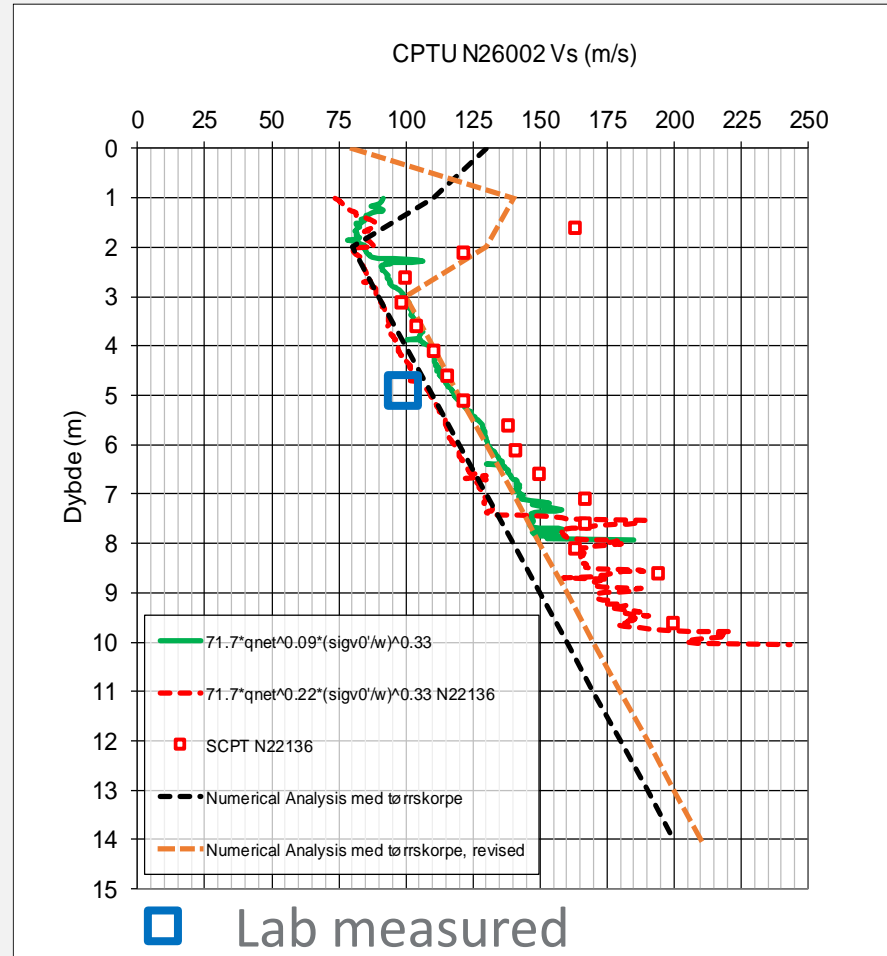
Estimated and measured shear wave speeds (N26002)

- Shear wave speed estimate at blast site. Dark Red line.
- Measured in lab 100 m/s with bender element (77 kPa eff. vertical stress)
- Varying depth to bedrock
- Assumed linear increase with depth of Vs

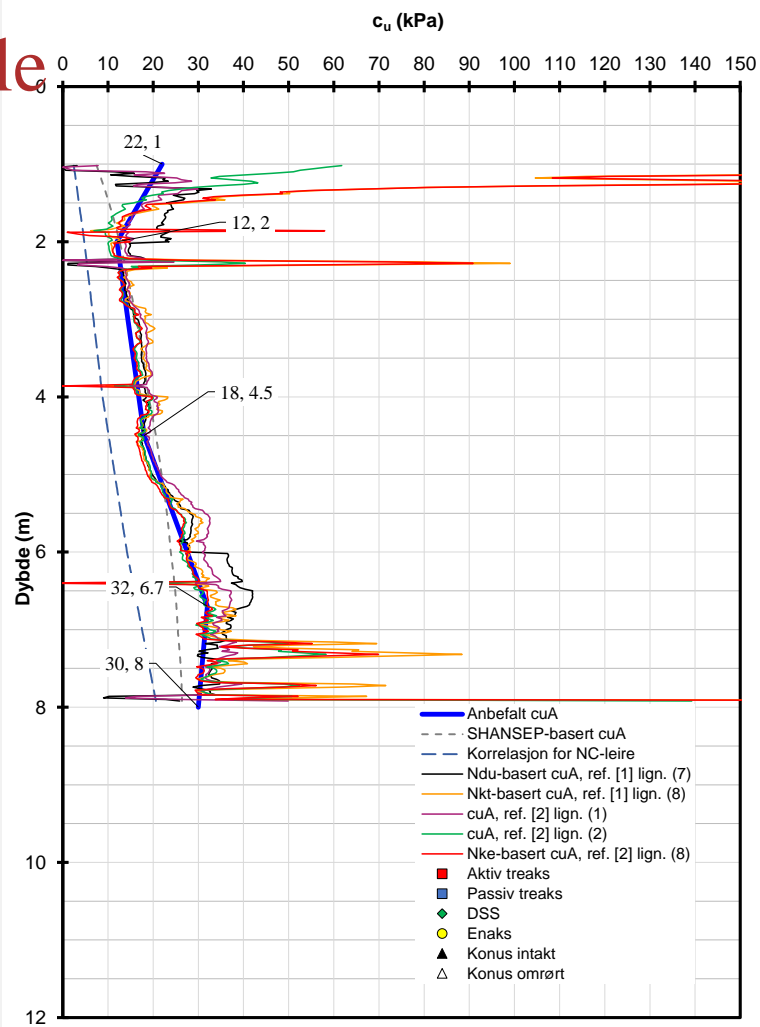
Undrained shear strength, SuA Profile

➤ $S_{u,DSS} = 0.65 * S_{u,Active}$ (compression)

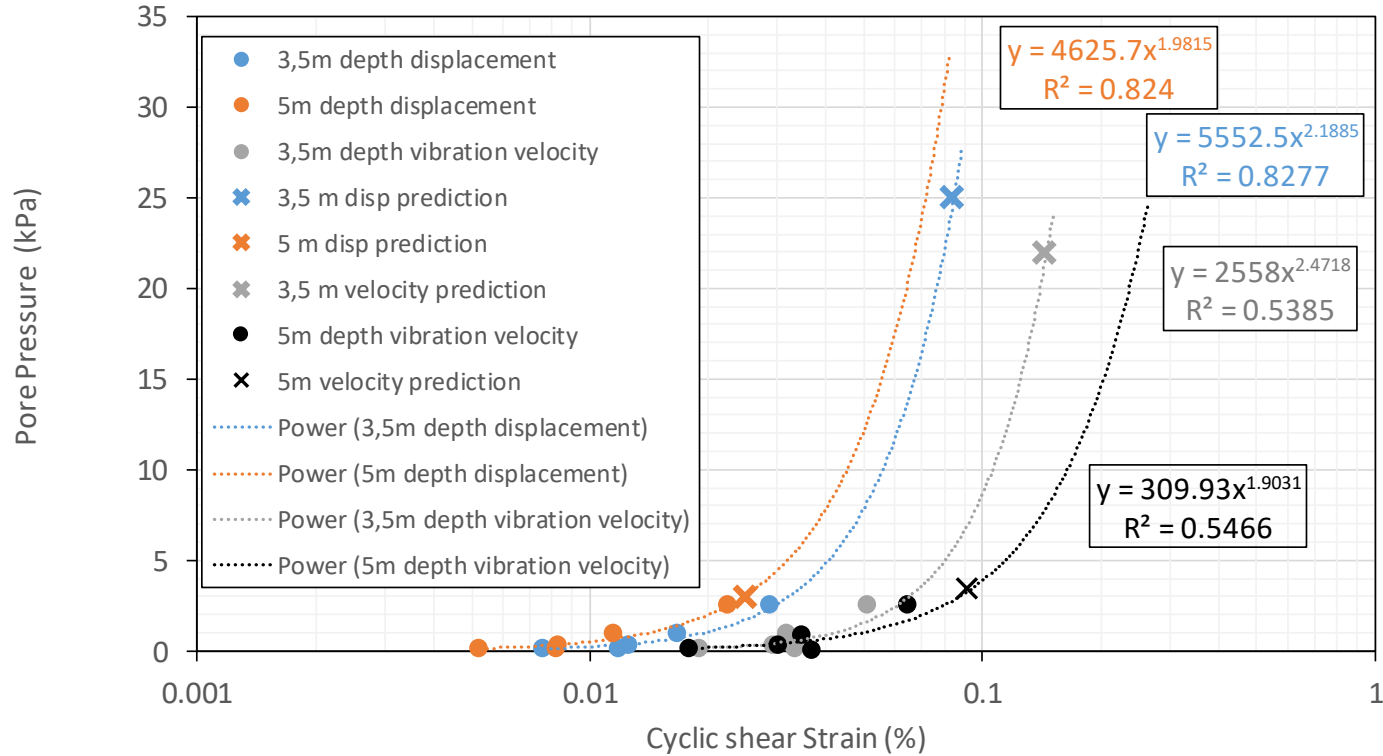
Measured pore pressures

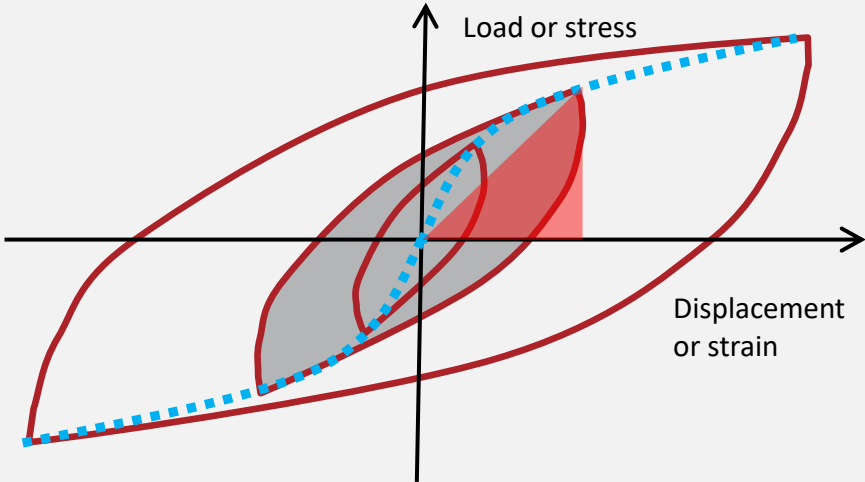
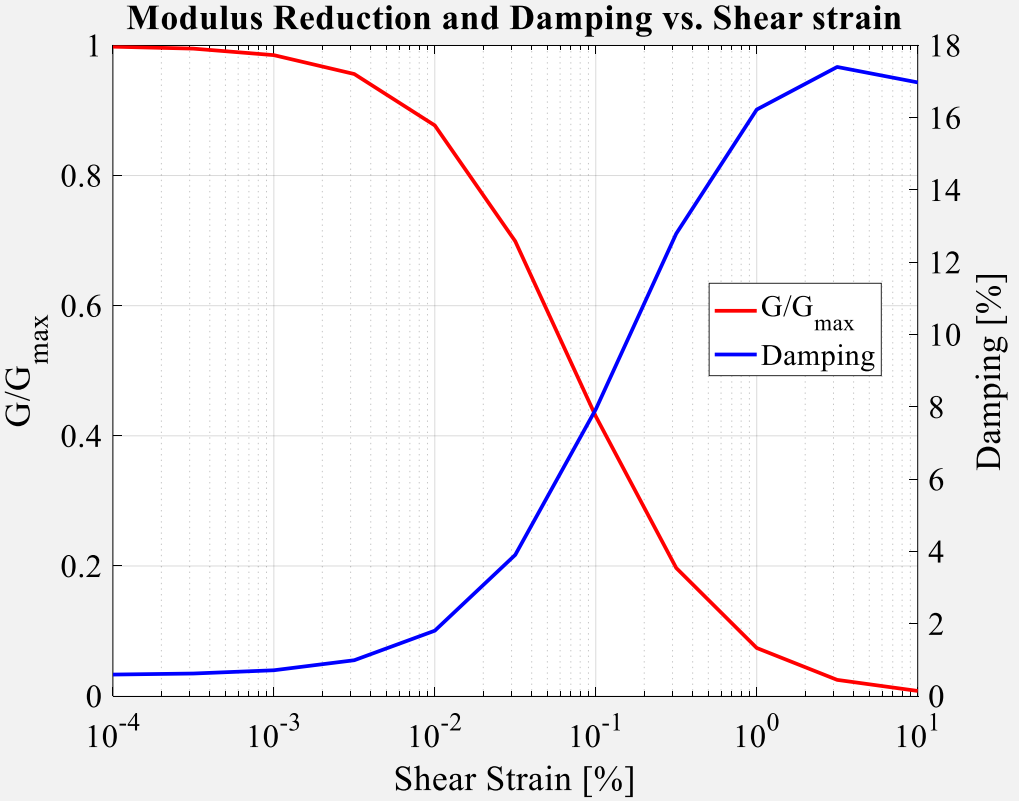
Soil Nonlinearity

Modulus reduction

- Quick clay test based in this for comparison
- Darendeli G/G_{max} in red for overburden effective stress of 60 kPa.
- Quick clay curves for about 80-90 kPa
- G/G_{max} curves sensitive due to uncertain G_{max} evaluations
