Case Studies in Challenging Geology: Gerede Water Tunnel & Delaware Aqueduct Repair

Presented by Brad Grothen PE, Technical Director

PRESENTATION OUTLINE CHALLENGING GEOLOGY

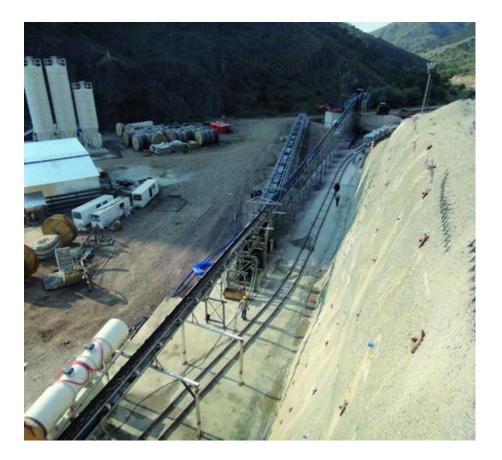
CASE STUDY: GEREDE WATER TUNNEL ORIGINAL TBM SUPPLY

- First attempt: Three standard 5.6 m
 Double Shield TBMs supplied by another manufacturer
- Each TBM would bore approximately 10 km of the tunnel

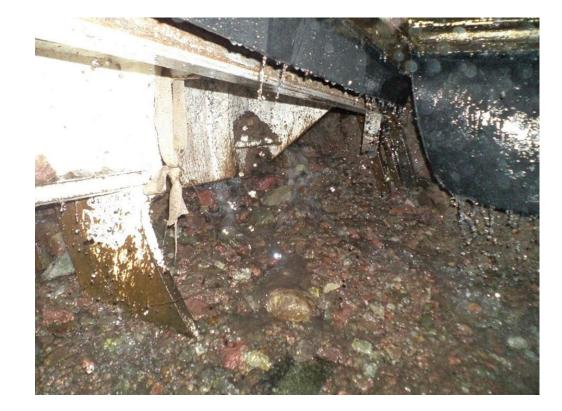
CASE STUDY: GEREDE WATER TUNNEL TBM 1 EXCAVATION

- + TBM 1 completed 9,588 m of tunnel in relatively homogeneous rock under low cover
- + Some water inflows and squeezing ground were encountered that caused delays, but did not trap the machine

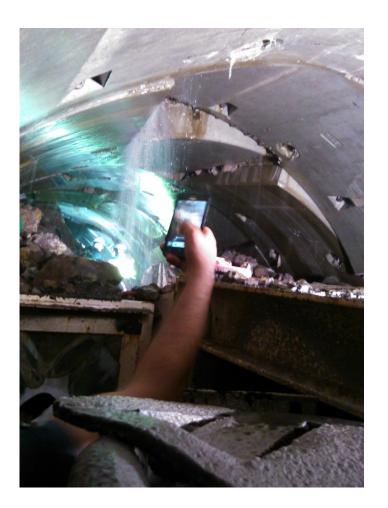
CASE STUDY: GEREDE WATER TUNNEL **TBM 2 EXCAVATION**

- TBM 2 had bored a significant section of its 10,339 m long tunnel when a massive inrush of water flooded the TBM and tunnel
- The TBM was boring downhill and the water had to be pumped out
- + The TBM was deemed a loss
- + Some parts were salvaged and the rest of the machine was removed

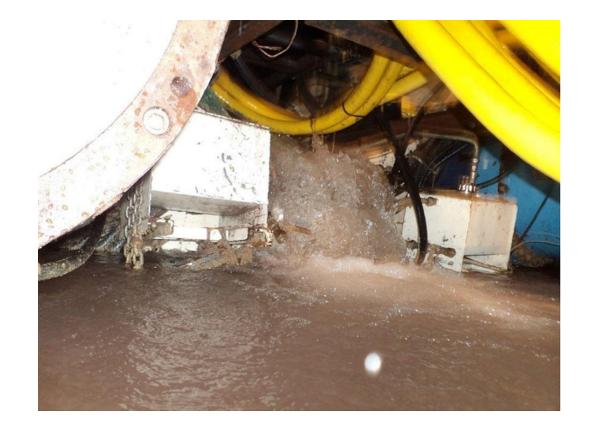
CASE STUDY: GEREDE WATER TUNNEL TBM 3 EXCAVATION

- + TBM 3 was several kilometers into its 11,653 m drive and struggling in karstic aquifer conditions that required polyurethane injection
- A sudden high inrush of water and mud, about 1,500 liters per second, flowed into the tunnel
- The pressure was enough to crush the TBM shields and send cylinders catapulting into the back-up
- + Dye tests showed the water had come from a river overhead and was entering the tunnel through a cave system
- + The machine was stuck in place

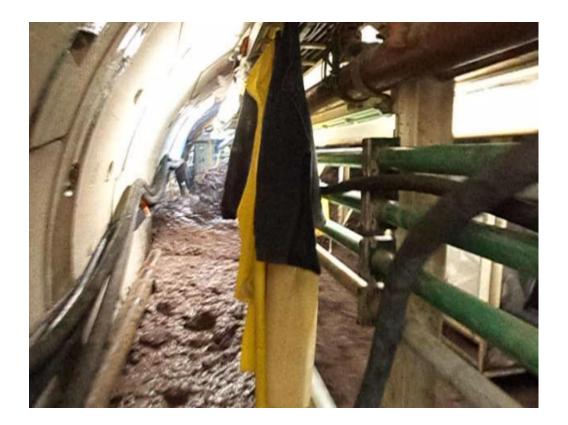
CASE STUDY: GEREDE WATER TUNNEL LESSONS LEARNED: DIFFICULT CONDITIONS

- One machine hit a fault zone, flooding and damaging the machine and collapsing the shield
- + The flooded machine was deemed not suitable to finish the tunnel
- + Another machine was damaged, though not as extensively, and stuck in place
- The standard Double Shield TBMs needed to be fully sealable against high water pressure

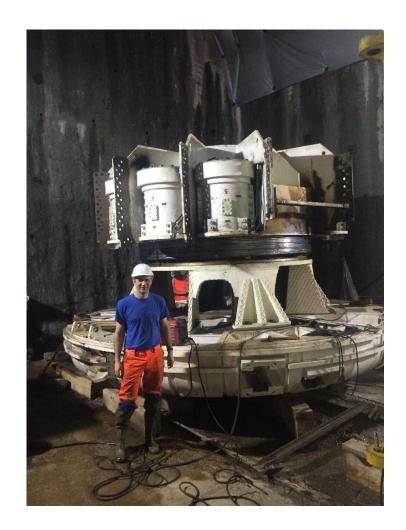
CASE STUDY: GEREDE WATER TUNNEL **NEW TBM SUPPLY**

- Robbins was selected to supply a 5.6 m diameter Crossover (XRE) type TBM to excavate 11 km of faulted and fractured rock with pressure up to 20 bar
- + Assembly of the machine onsite in the tunnel
- + Reuse existing backup and system components

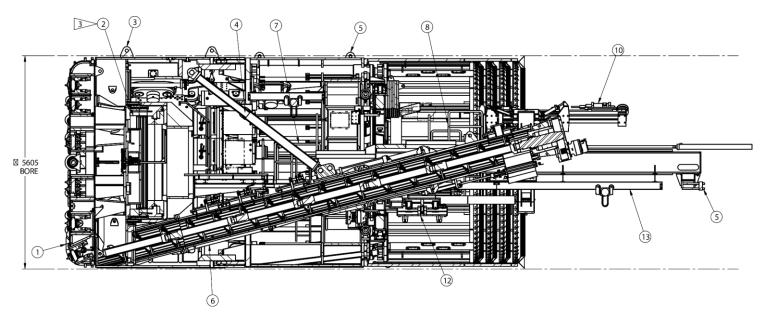
CASE STUDY: GEREDE WATER TUNNEL

TBM FEATURES

- + Crossover (XRE) TBM with Single Shield and EPB TBM characteristics
- + High strength shield with closed bulkhead to resist water and mud inflows
- + Bottom screw conveyor

- + High pressure articulation and tail seals
- + High thrust capacity
- + Multi-position probe drilling

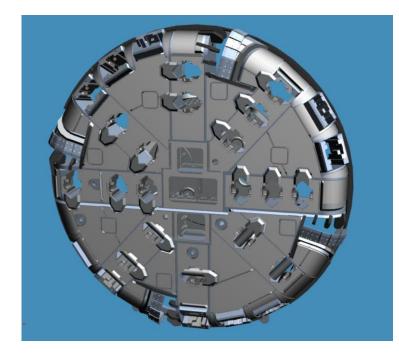
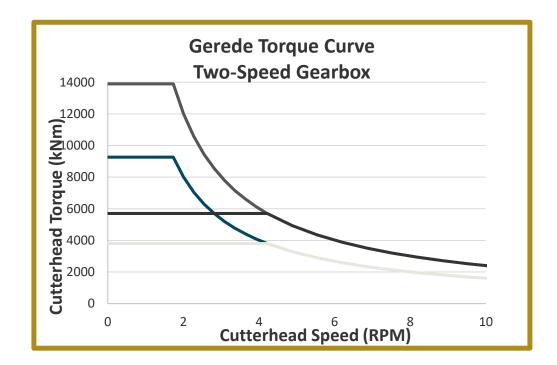
CASE STUDY: GEREDE WATER TUNNEL CUTTERHEAD

- + Single-direction rock cutterhead
- + Dual ratio transmission for high torque capability

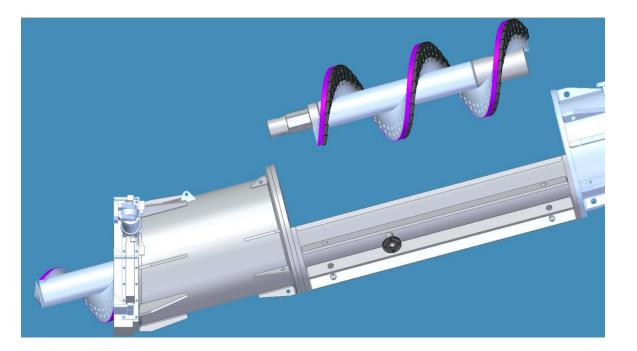
CASE STUDY: GEREDE WATER TUNNEL SCREW CONVEYOR DESIGN

- + Sealing system to seal itself off so TBM could continue boring through fault zones
- + Replaceable wear plates to protect against highly abrasive rock
- Removable sectional casings that could be replaced if needed

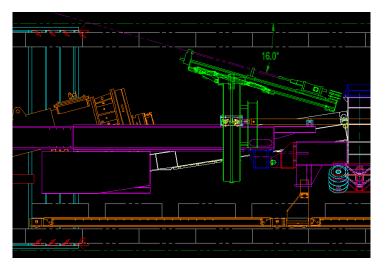
- + Necessary to detect and grout off zones of concern
- + TBM has twelve Ø100 mm sealed ports angled at 7° that are equally spaced around the rear shield and ten Ø100 mm ports through the forward shield
- + There are six hatches built into front of machine
- In emergencies, the drill can pull back behind the tail shield at an angle of 16°, so it can drill behind the shields and into the segment lining

Probe drilling through a port in the machine shield

Probe drilling behind the tail shield

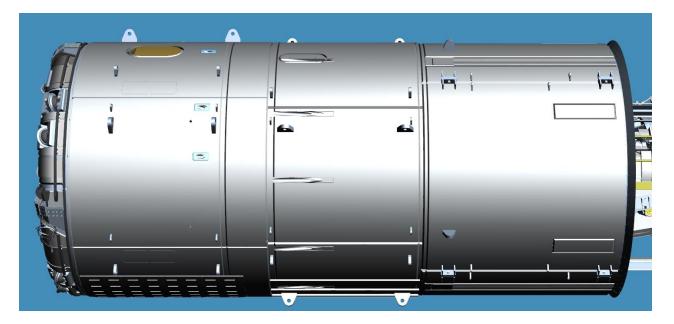
- + Stepped shield design
- + Peripheral shield lubrication

View of stepped shields

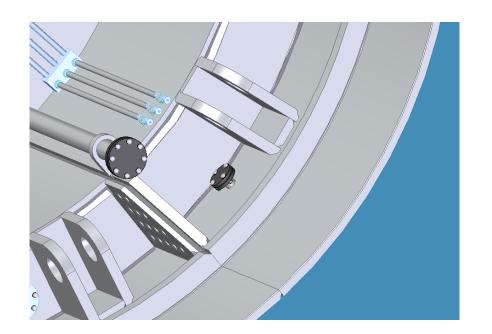
Peripheral shield lubrication port

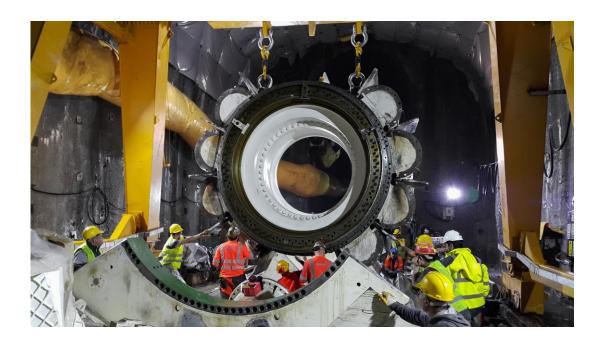
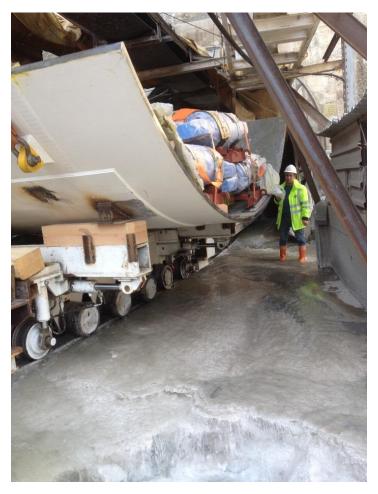
CASE STUDY: GEREDE WATER TUNNEL TBM ASSEMBLY

- + TBM was assembled in a chamber 7 km from the tunnel portal
- + Segment ID 4.5m
- + Water flow inside the tunnel averaged 500 l/s during the assembly process
- + Existing machine and back-up were still in place

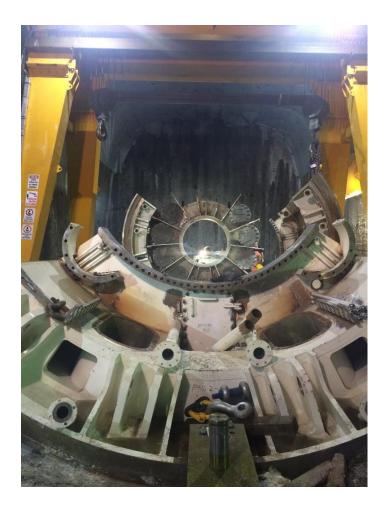
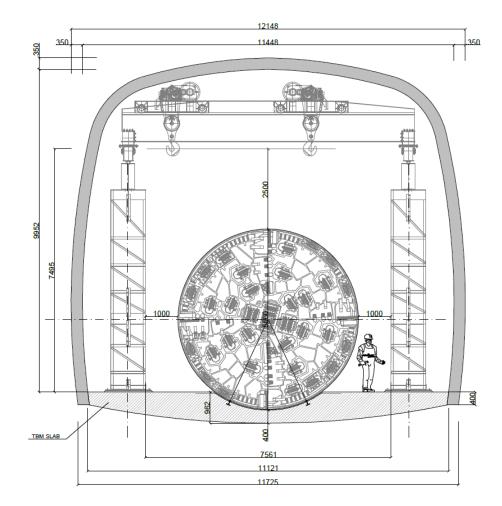
ASSEMBLY INSIDE CHAMBER

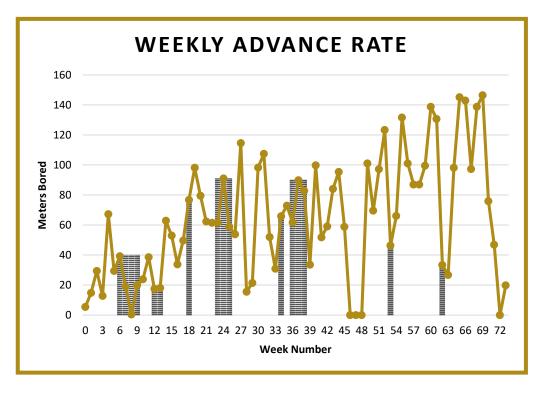
CASE STUDY: GEREDE WATER TUNNEL TBM ADVANCE

- + Machine launch was in summer 2016
- The geology was variable and the TBM was boring basalt, tuff, medium to hard clay, and sandy clay with excessive groundwater
- Water flow inside tunnel was 450-570
 I/sec and strained logistics including rail transport
- + First 72 weeks of tunneling, noted in chart, were highly variable

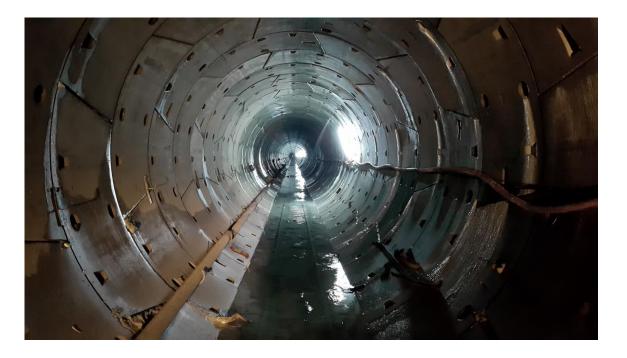
CASE STUDY: GEREDE WATER TUNNEL TBM ADVANCE

- + TBM ultimately bored through 48 fault zones
- Statically held water pressures up to 26 bar, as well as alluvial material in fault zones
- Ground pressure on the shield body caused squeezing conditions in clay
 - + TBM was able to pass through squeezing ground by keeping TBM advance rate, Cutterhead RPM, and screw conveyor rotation speed at optimal levels

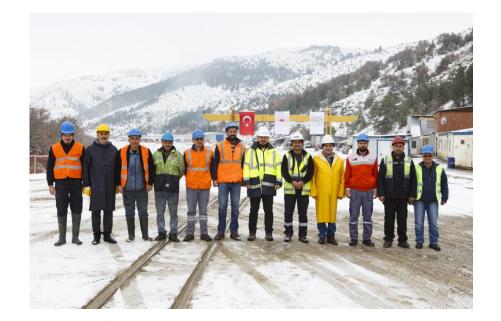
- + Breakthrough occurred on December 18, 2018
- Machine achieved good advance rates for the conditions, up to 484 m in one month

Best Day	29.4 m	Average Day	9.49 m
Best Week	134.6 m	Average Week	71.14 m
Best Month	484.0 m	Average Month	284.54 m

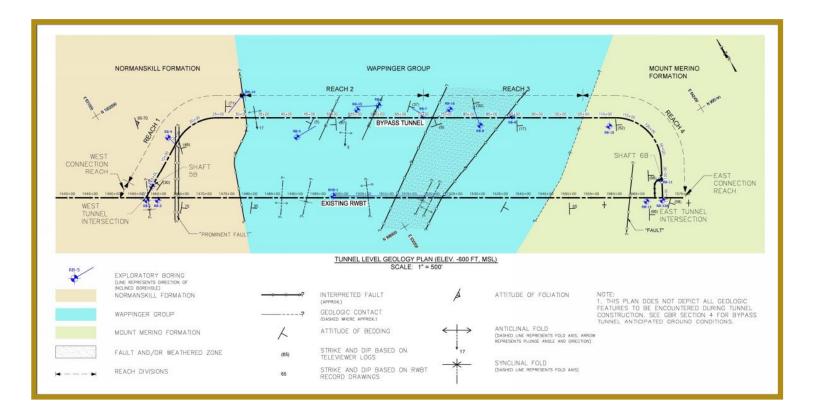
Geology

- + Reach 1-780m Shale
- + Reach 2-1189m Limestone
- + Reach 3-1067m Limestone
- + Reach 4-774m Shale
- + Hard Rock Tunnel
 - + Maximum UCS of 54 ksi (372 MPa)
 - + Average UCS of 35 ksi (241 MPa)
- + Fault Zones
- + Squeezing Ground

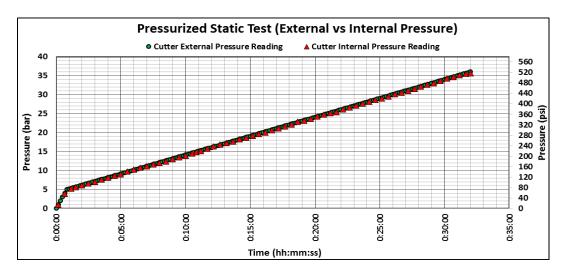
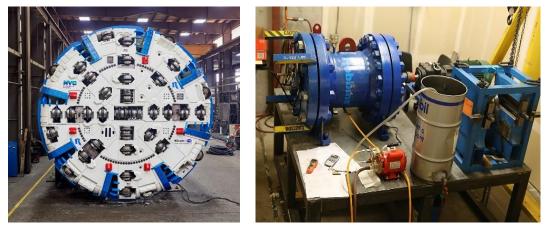
Operational Challenges

- Main bearing seals capable of withstanding 35 bar (435psi) static pressure
- + Pressure compensated disc cutters installed
 - Testing surpassed 30 bar static capability

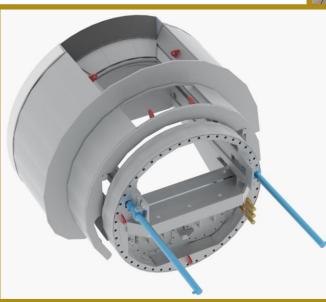
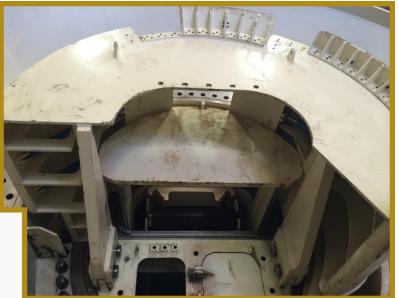
Sealing of Conveyor Opening

- + Knife gates to block incoming muck
- + Retractable conveyor
- + Retractable gate with inflatable seal
- + Provisions made to pull extra belt out of the way

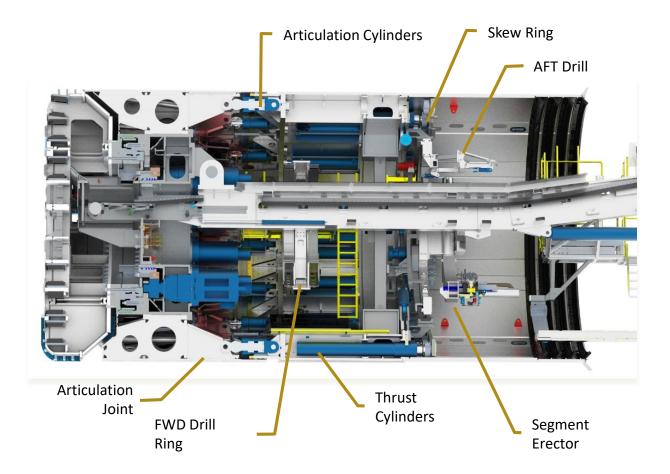
Shield Sealing

- + Three articulation seals required
- + Four tail seals
 - Erector is designed to remove segments so all four brushes can be removed from inside tunnel
- + Sealed stabilizers and grippers

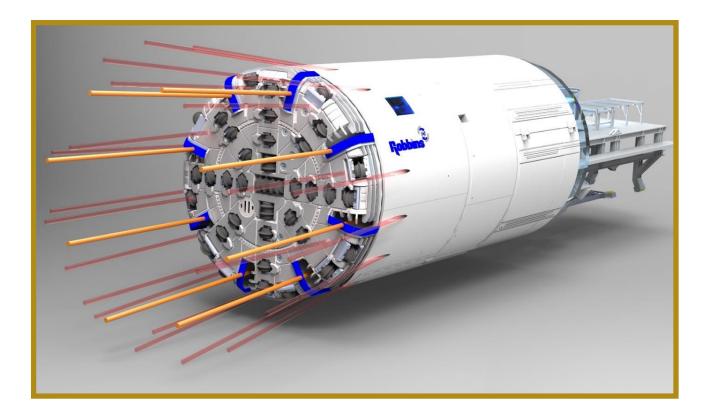
Drill Ports

+ Cutterhead

- + 4 ports at 0 degrees to alignment
- + 12 ports at 4 degrees to alignment
- Cutterhead automatically positions it self between two different drill positions
- + Radial Ports
 - + 14 ports at 7 degrees

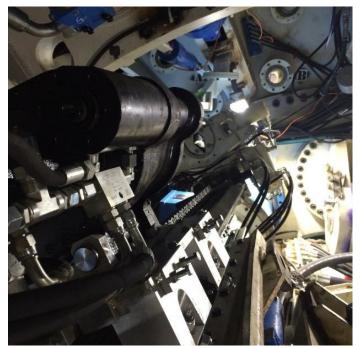
Drills

- + Down-the-hole water hammers
 - + Straighter drilling vs top hammer drifters
 - + Advantageous for longer holes

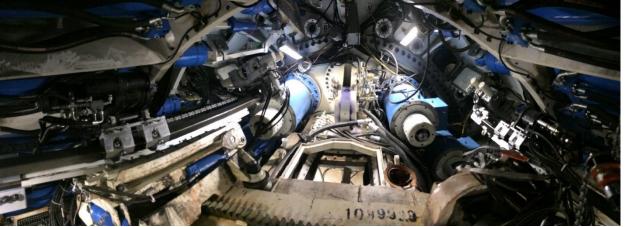
Forward Drills

- + Contained inside of rear shield
- + 2 separate drills with 360-degree freedom of movement
- + Can drill in both the horizontal and 4-degree ports
- + Large freedom of movement for locating drills
- + Special provisions made during plumbing to avoid contact with drills
- + Bulk of drilling duties will be carried out by forward drills

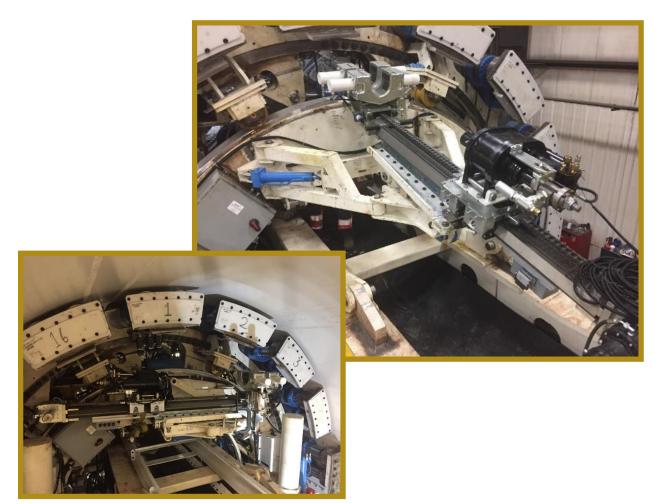
Rear Drill

- + Mounted on erector
- Positioned to drill through 14
 radial ports located evenly
 spaced around 360 degrees
- + Folds to stored position close to erector

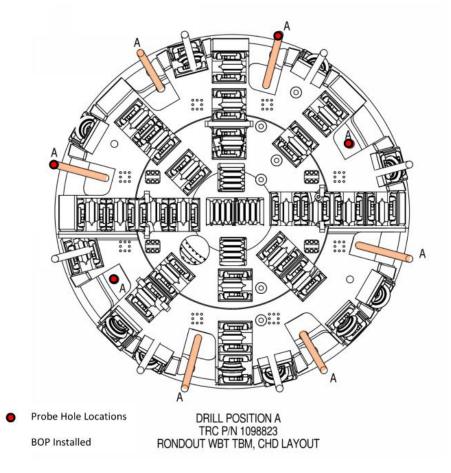
- + 2 probes in reach 1 and 4
- + 4 probe holes in reach 2 and 3
- + 200 ft hole depth
- + 20ft overlap
- + 5 ft drill steel

Figure 1. BOP Locations on drill position A

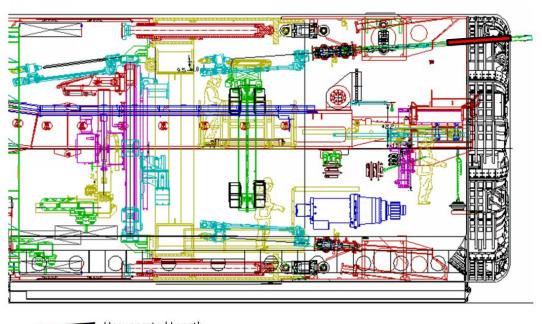
- + Use W70 (89mm) to drill 6-10ft
- + Install tail pipe packer and clamp with BOP
- + Use W50 to drill through packer

Figure 2. TBM Cut Section Drilling locations.

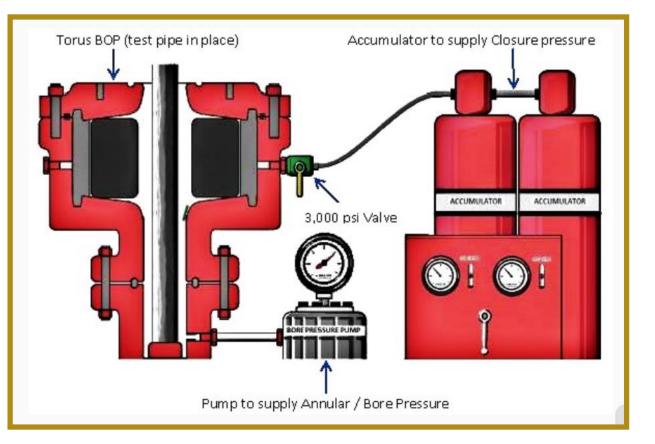
5-inch Regan Torus valves on drill ports

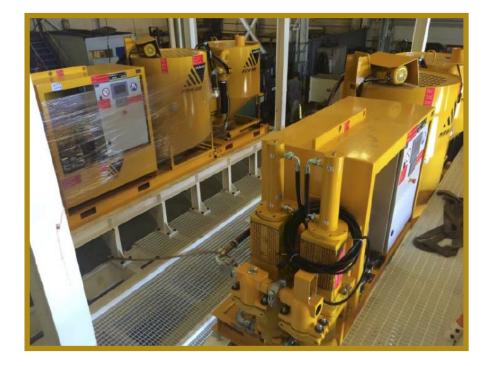
PEG Grouting

- + 30 GPM grout trigger
- + Grouting material
 - + Type III cement
 - + Ultrafine if needed
- + Grouting procedure
 - + Mix 4:1
 - + 15 min < 10% pressure build
 - + Grout pressure 50 psi over hydrostatic
 - Typical max grouting pressures 1psi/ft overburden

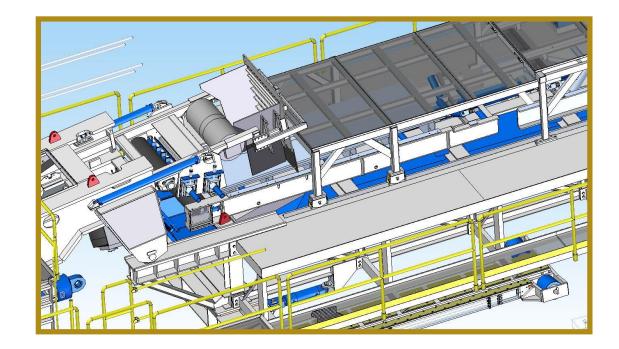
Rear Drill

- + Open Conveyor
 - + Troughed rollers
 - + Full flashing
- + Catch basin at transfer point to catch water runoff

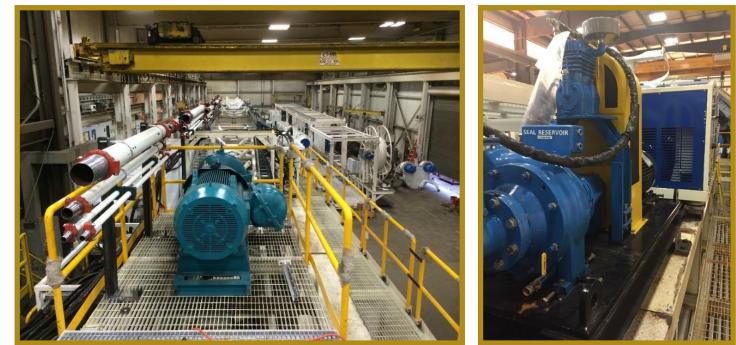
De-watering | De-mucking

- + Controls water inflow in two conditions
 - + Boring: 0 800 gpm
 - + Emergency: 1700 gpm
- + Pickup locations:
 - + Cutting chamber
 - + Drill water
 - + Invert of TBM
 - + Ring build area
 - Catch basin below conveyor transfer

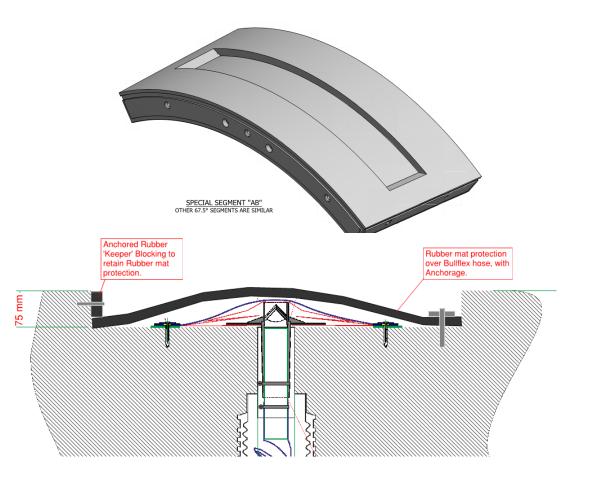
Bullflex Ring

- + Built with erector
- Once exposed, grout will be used to inflate hose
- + Seals annulus to resist water/grout forward when TBM is sealed up

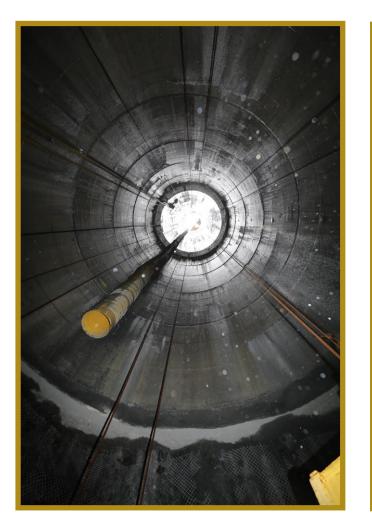
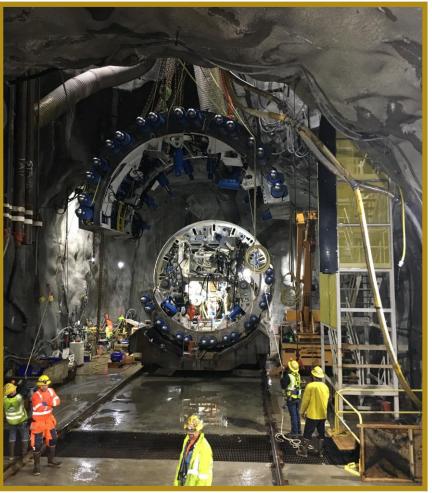
Assembly & Launch from Deep Shaft

- Components were lowered down the 270 m deep Newburgh shaft
- + TBM was assembled in a bell-out chamber with 12 m high ceiling

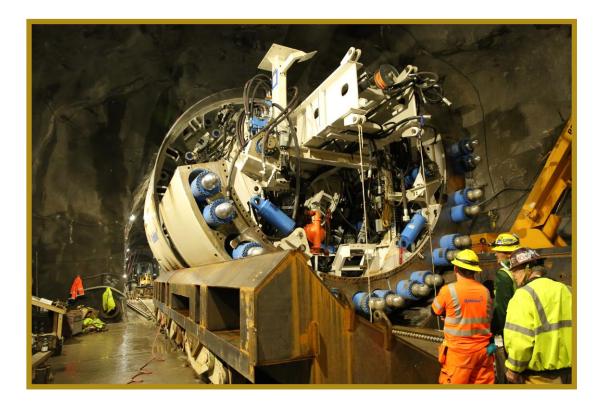
Launch & Water Mitigation

- The TBM was launched on January 8, 2018
- Contractor KSC performed extensive pre-excavation grouting to mitigate the 4,900 l/min predicted in the GBR
- The highest inflows encountered were 1,300 l/min and 200 psi was the highest pressure, a good result in part because of the dewatering effort

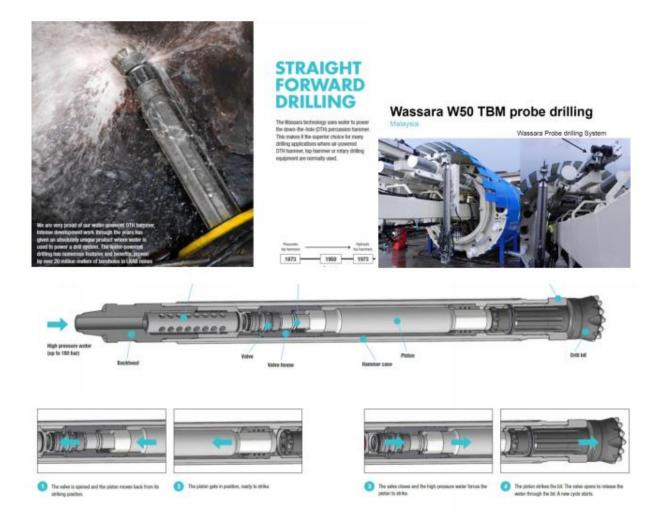
DTH Hammers

- + Used throughout the drive
- Probed 120 m ahead of the TBM at 115 m intervals
- Upkeep was challenging as the drill water had to be kept clean and filtered like hydraulic fluid, but ultimately the crew overcame the learning curve
- + Saved time and had less deviation from tunnel alignment than top hammer drills

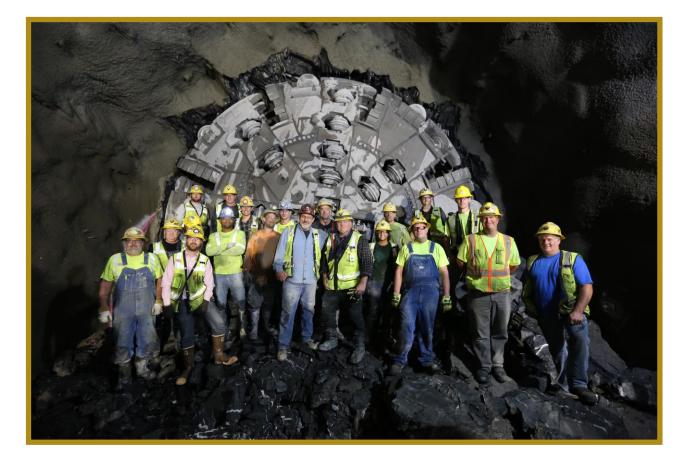
Excavation Rates

- + TBM bored at rates of 100 mm/min
- + However, the shaft became a bottleneck particularly towards the end of tunneling because of the train travel time and muck cars, which were lifted out of the shaft
- The TBM achieved 27.4 m in one day, 108.1 m in one week, and 288 m in its best month
- + Breakthrough occurred in August 2019
- Work is ongoing to install a steel interliner in 2,800 m of the tunnel as well as a final concrete lining
