How to build a water tight segmental lining in Scandinavian conditions

Vanntette elementløsninger i TBM tunneler

Robert Sturk

Technical Advisor, Skanska Sverige AB,
Stora projekt

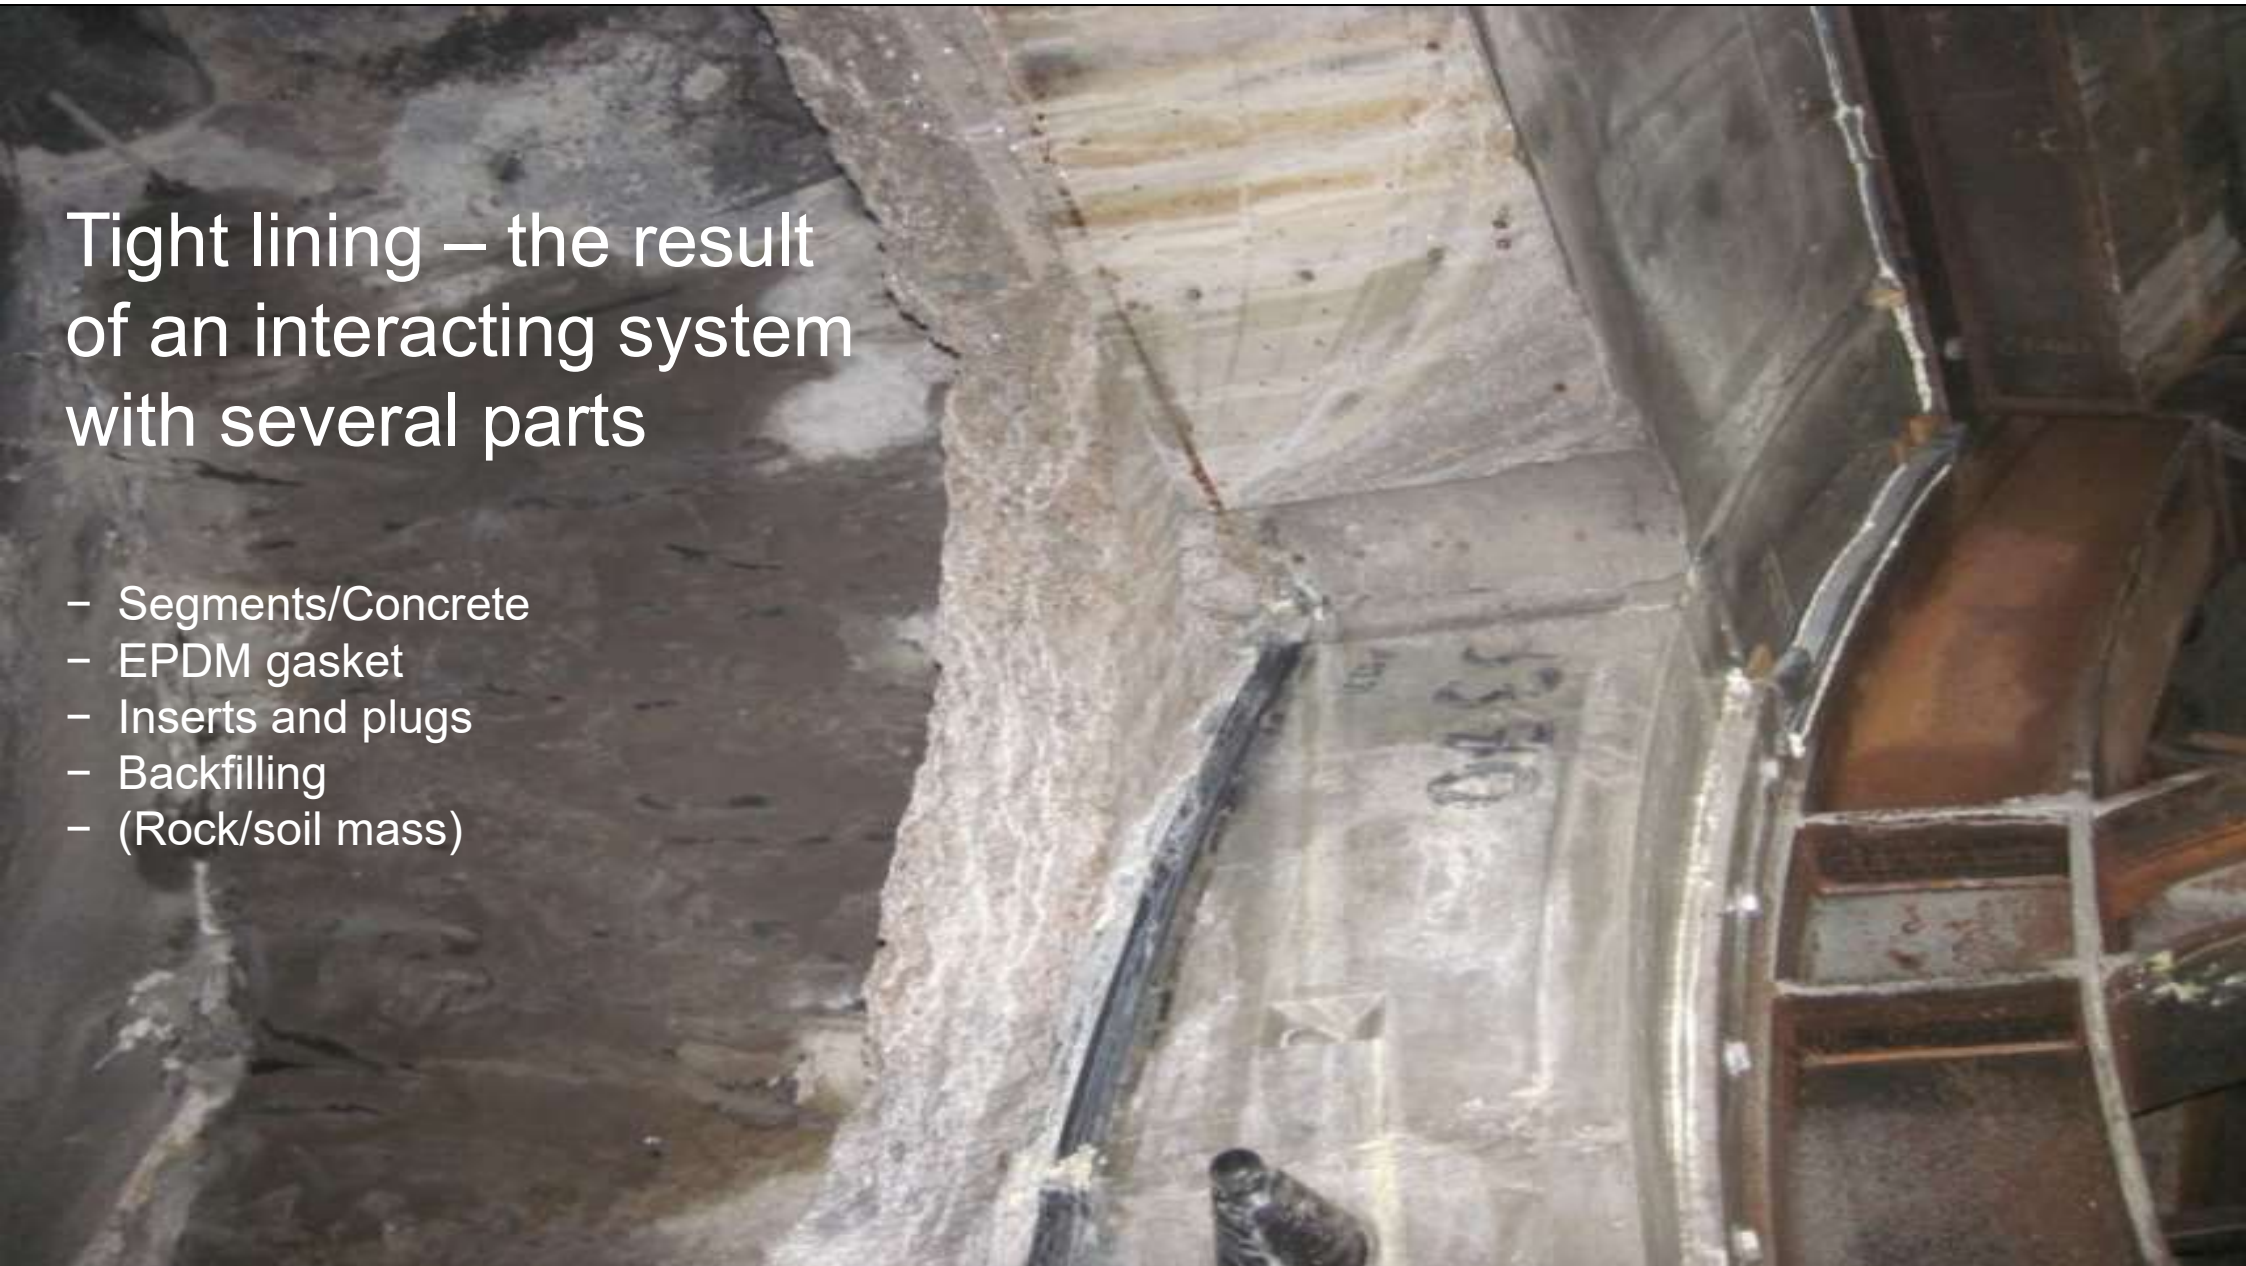
Tight lining – the result of an interacting system with several parts

- Segments/Concrete
- EPDM gasket
- Inserts and plugs
- Backfilling
- (Rock/soil mass)

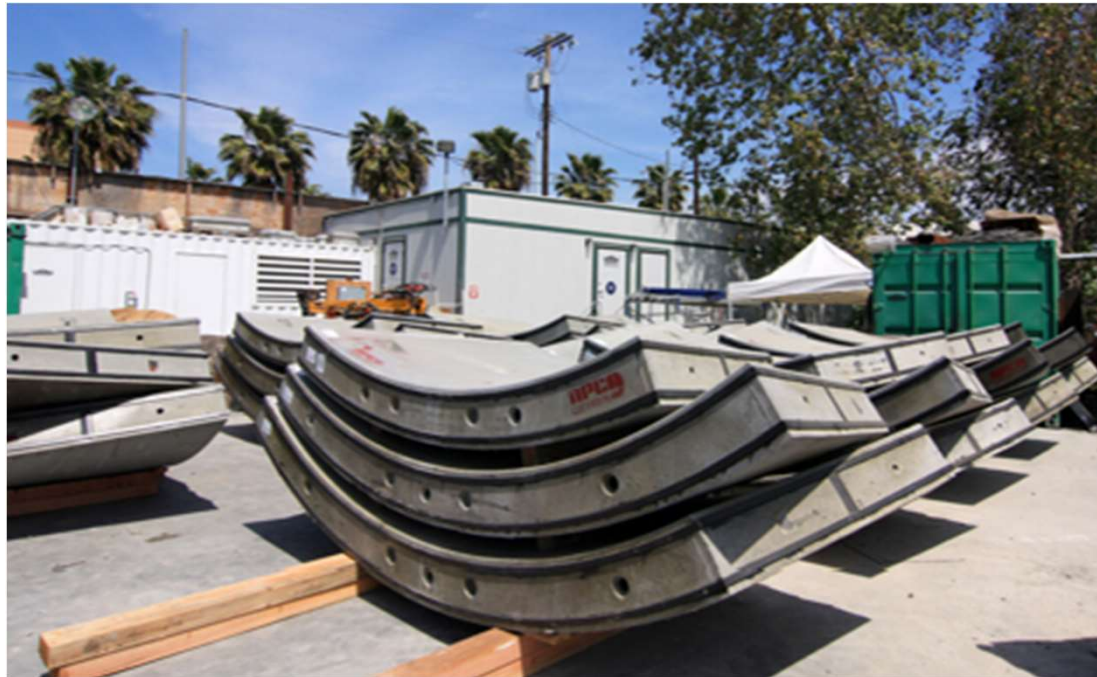
Double gaskets

Example of double gasket system, but criteria was risk of gas as opposed to watertightness.

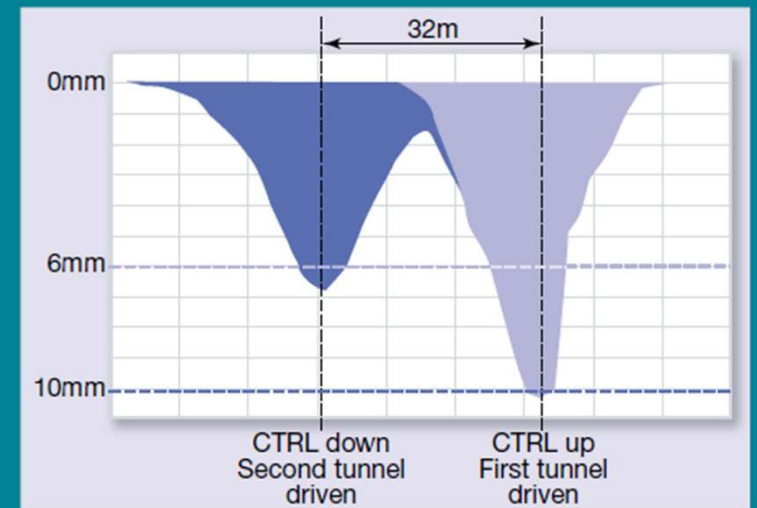
Above: Graph showing the settlement figures achieved during the underpass of the 70 year old Central Line Tunnels

A full emergency plan and cascade of reactions to monitoring was established and a hot line set up between the monitoring review team and the line controller. The tunnels passed beneath the Central Line with approximately 10mm as the maximum settlement equating to approximately 0.3% ground loss.

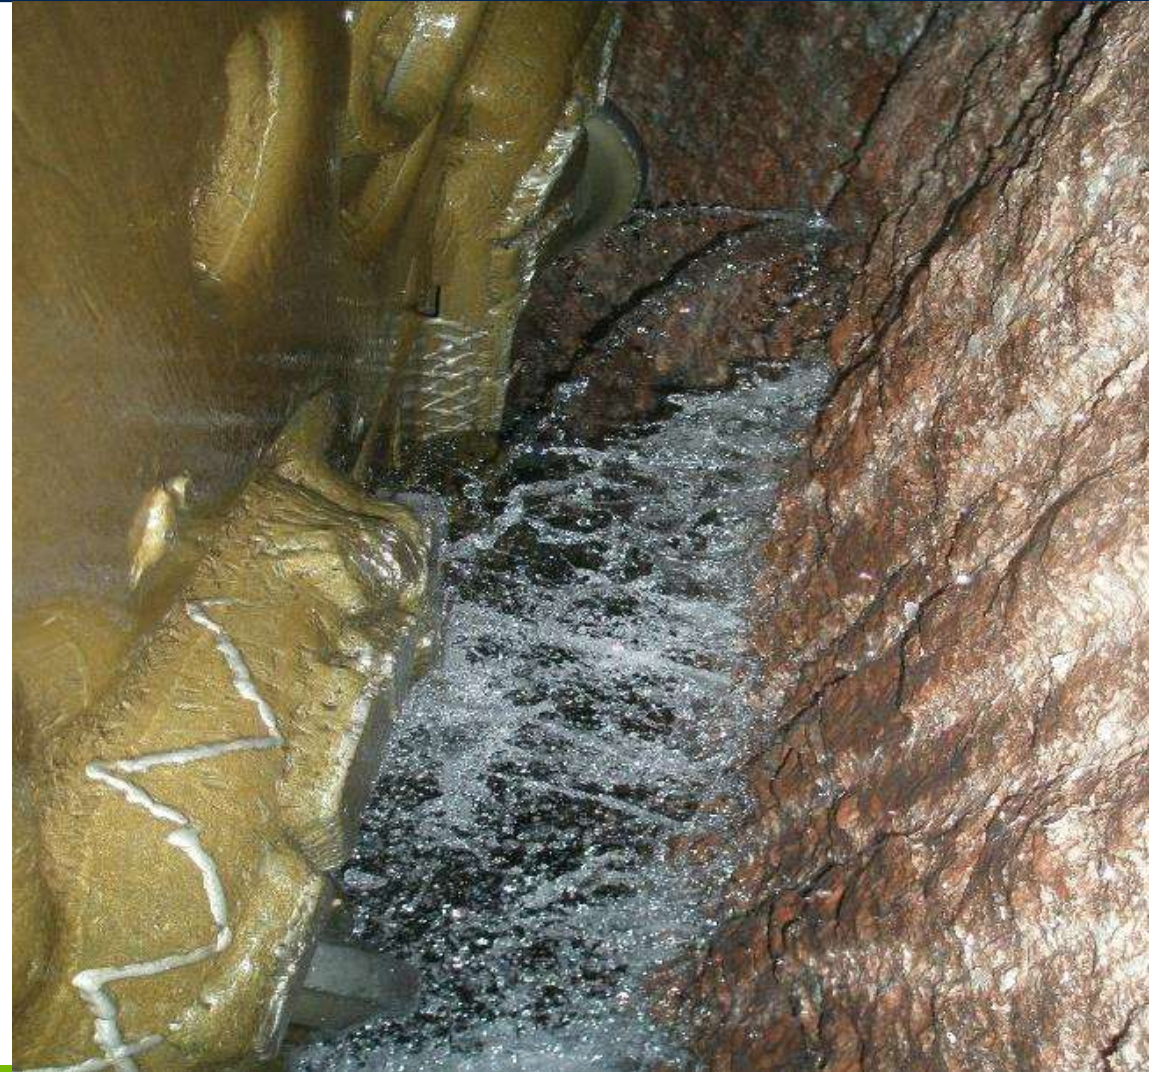
Uplift

- Monitoring revealed that the lining was uplifted (all the way up to the roof)
- Practically no backfill left in some sections
- The lining was damaged

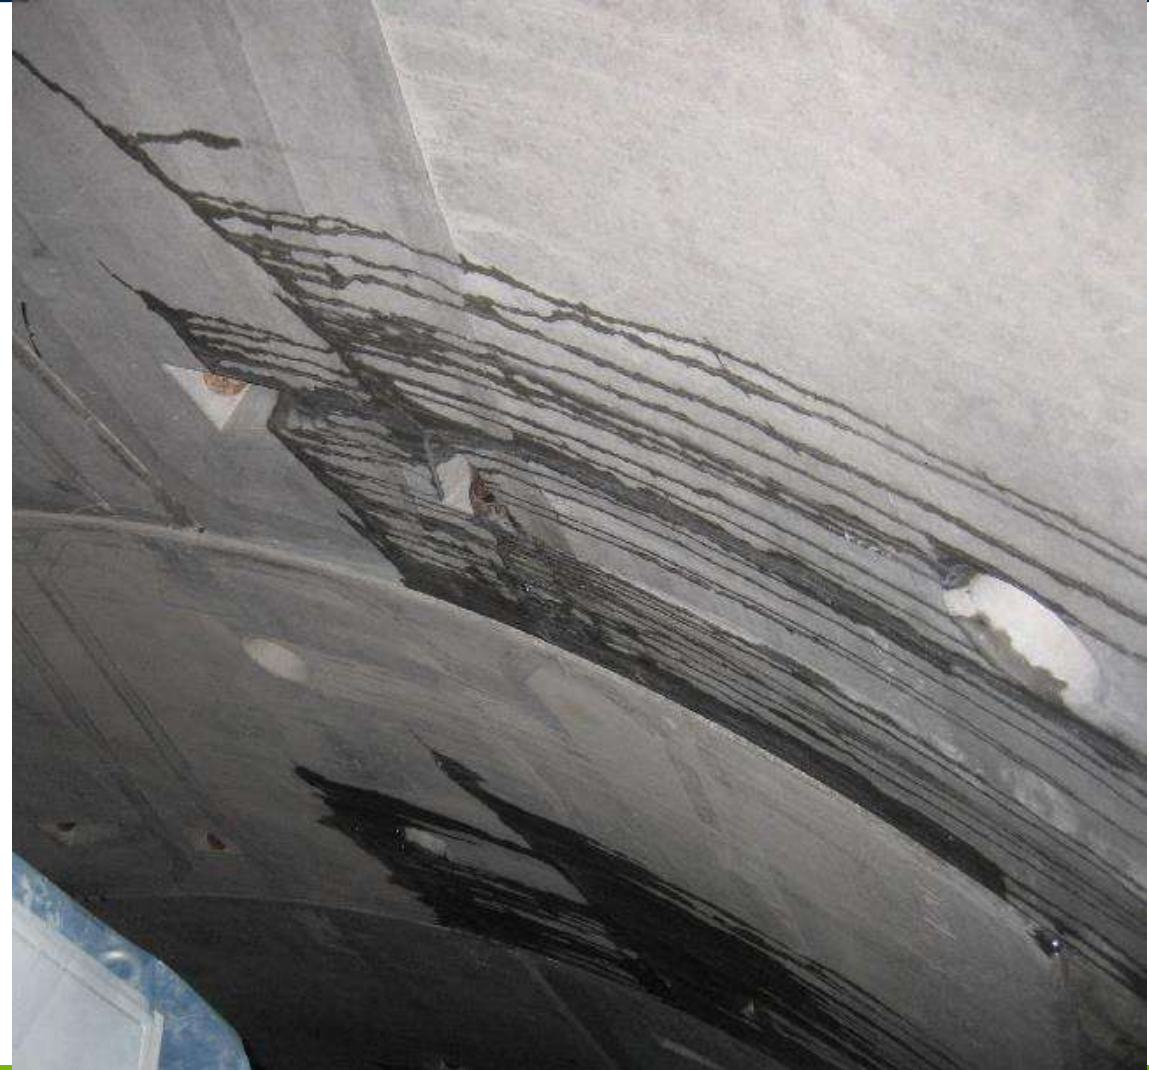
The solution

- Pea gravel (ensgradert grus) in combination with mortar
- In difficult situations it is necessary to regularly build tight barriers
